COCOS LAGOON ABANDONED TIRE REEF REMOVAL PROJECT

PRINCIPAL INVESTIGATORS:
GUAM ENVIRONMENTAL PROTECTION AGENCY
AND
GUAM DEPARTMENT OF AGRICULTURE

Funded by NOAA Marine Debris Grant (NA19NOS9990031)

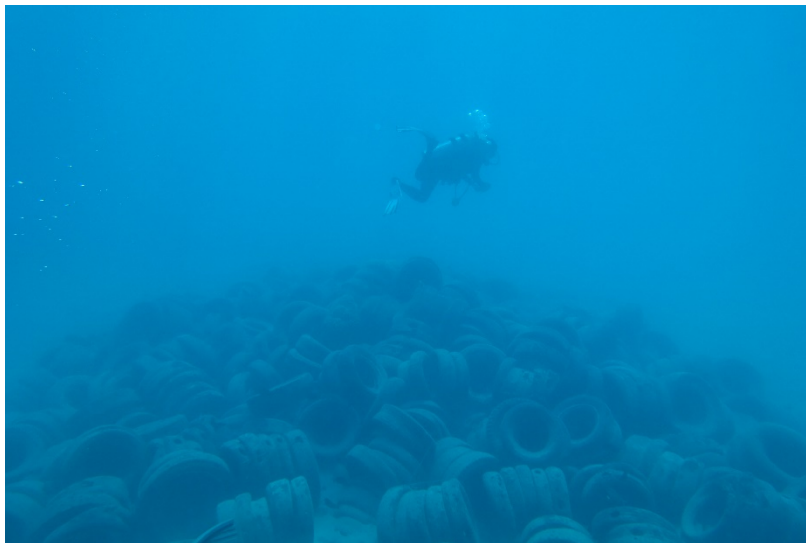
General view of CARB. (Photograph courtesy of GEPA).

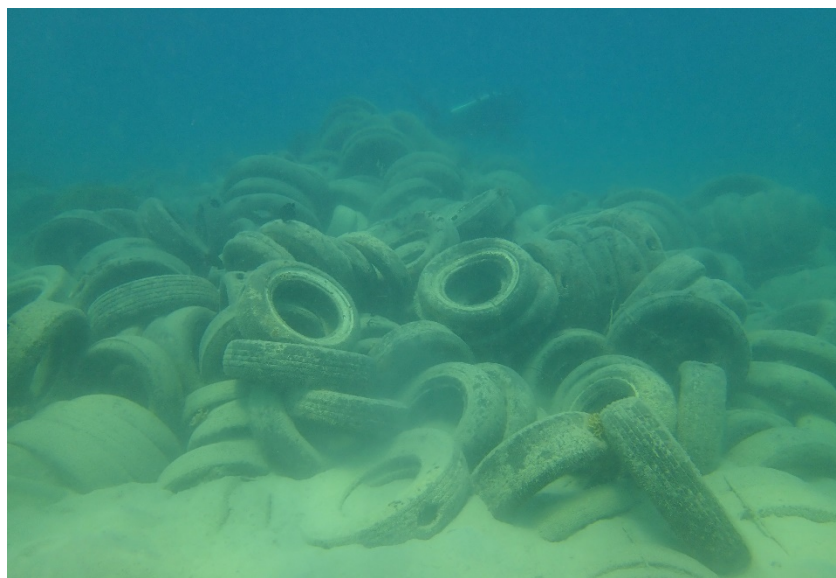
CARB (SIDE VIEW). (Photograph courtesy of GEPA).

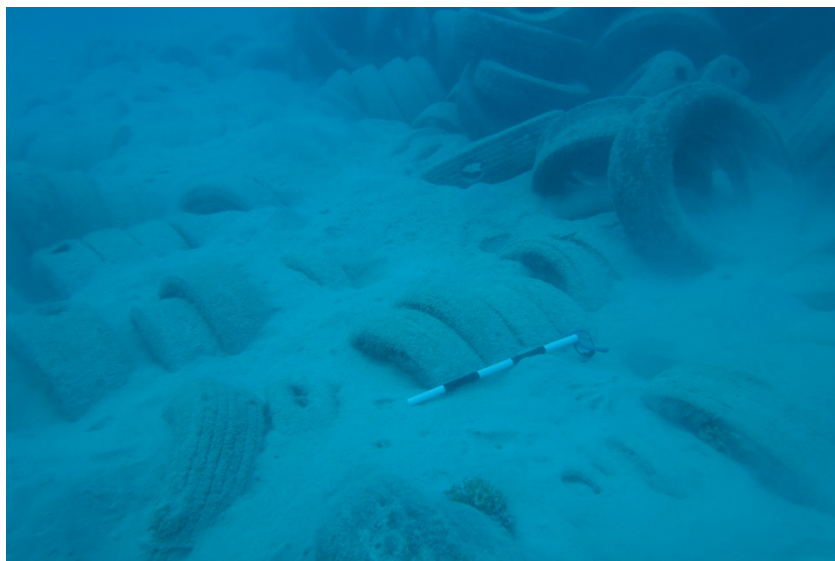
Groups of tires buried under sediment at CARB. (Photograph courtesy of GEPA).

to achieve a 15 foot vertical tire reef mound. Recent assessments show that the current state of this site is about 5 feet shorter than its initial installation in the 1970's. Approximately one tire tube layer appears to be buried underneath the sediment surface.

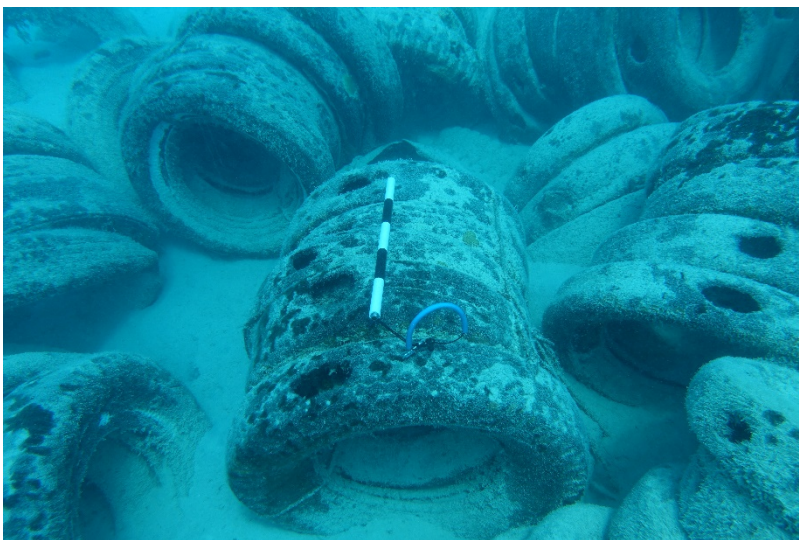
Close-up of CARB. (Photograph courtesy of GEPA).

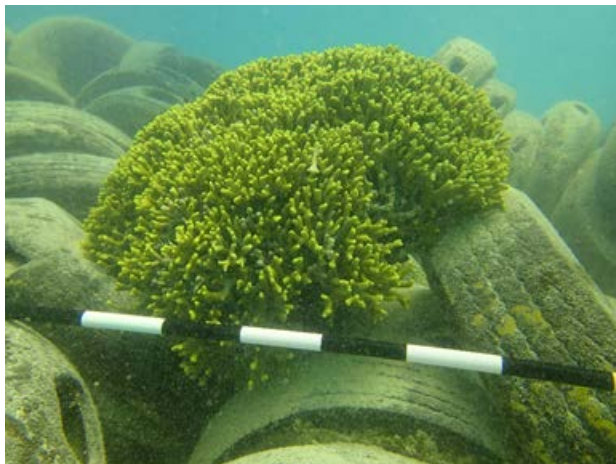
Largest Non-encrusting coral feature, *Porites cylindrica*, prior to transplantation (Photograph courtesy of GEPA).

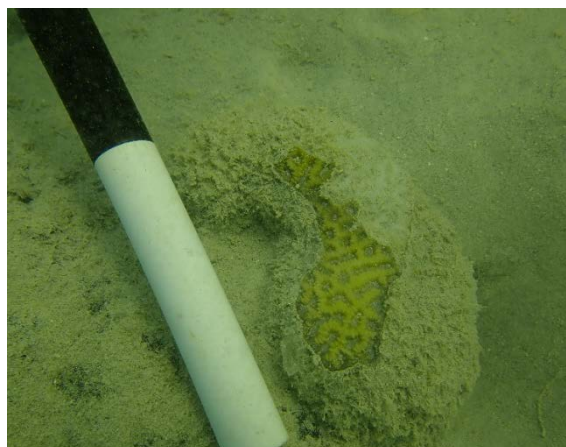
Example of coral feature, *Platygyra sp.*, prior to transplantation (Photograph courtesy of GEPA).

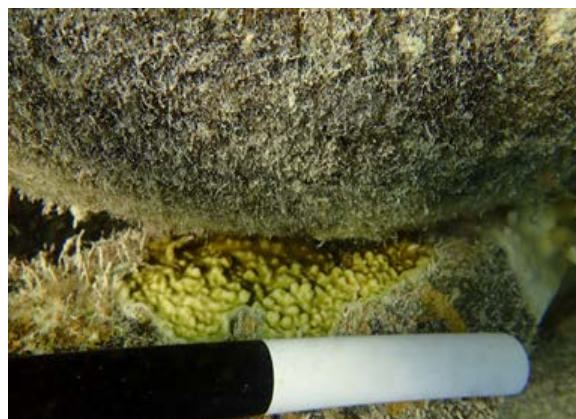
Example of encrusting coral feature, *Leptoseris incrustans*, prior to transplantation (Photograph courtesy of GEPA).

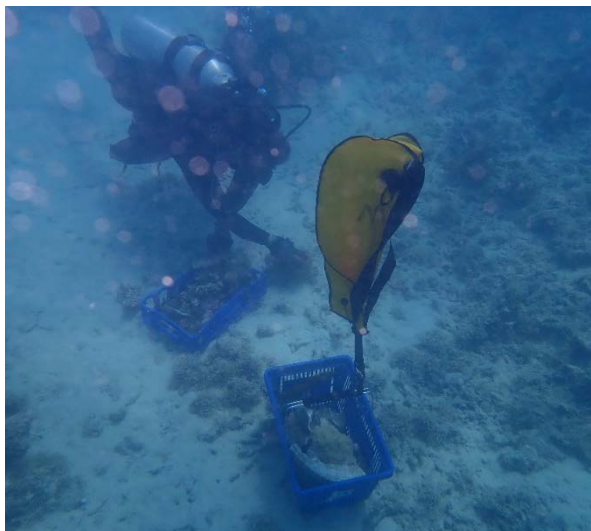
Divers collecting Coral fragments for transplanting (Photograph courtesy of GEPA).

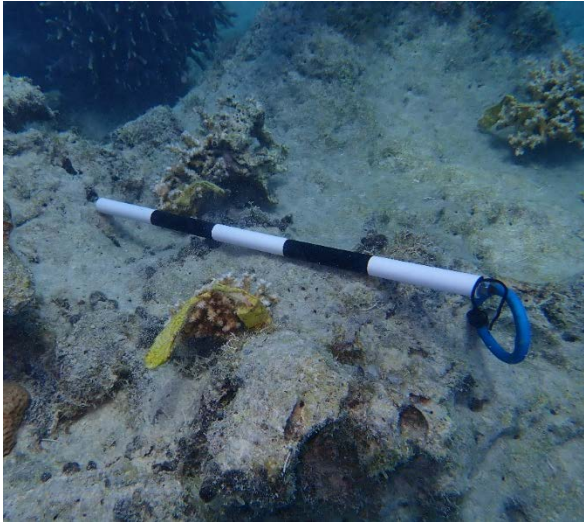
Coral fragments reattached at transplant site with concrete. (Photograph courtesy of GEPA).

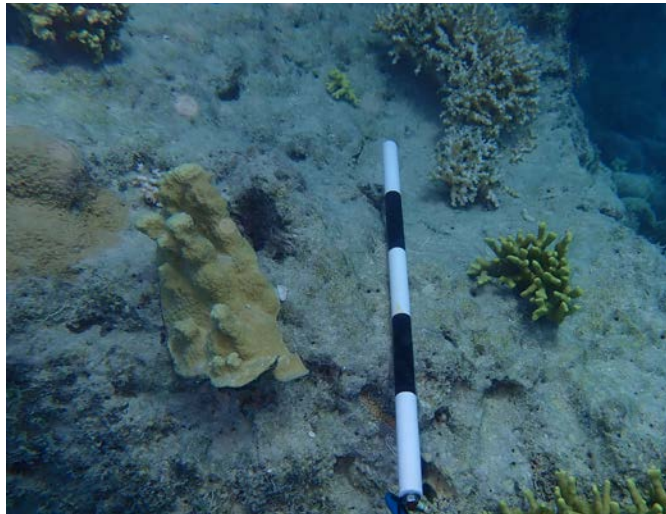
Coral fragments reattached at transplant site with concrete.
(Photograph courtesy of GEPA).

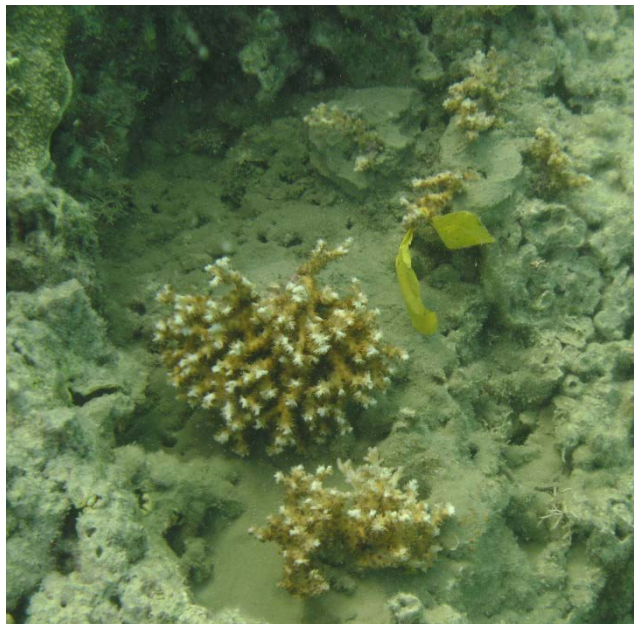
Coral fragments reattached at transplant site with concrete.
(Photograph courtesy of GEPA).

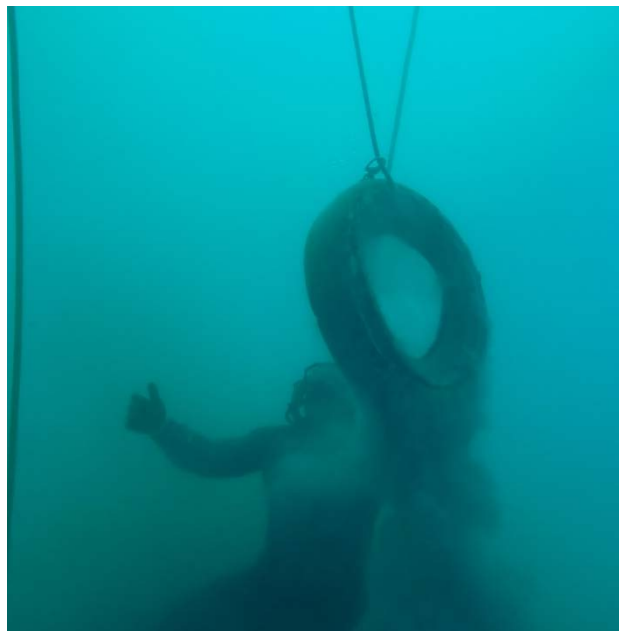
Tire retrieval. (Photograph courtesy of Guam EPA).

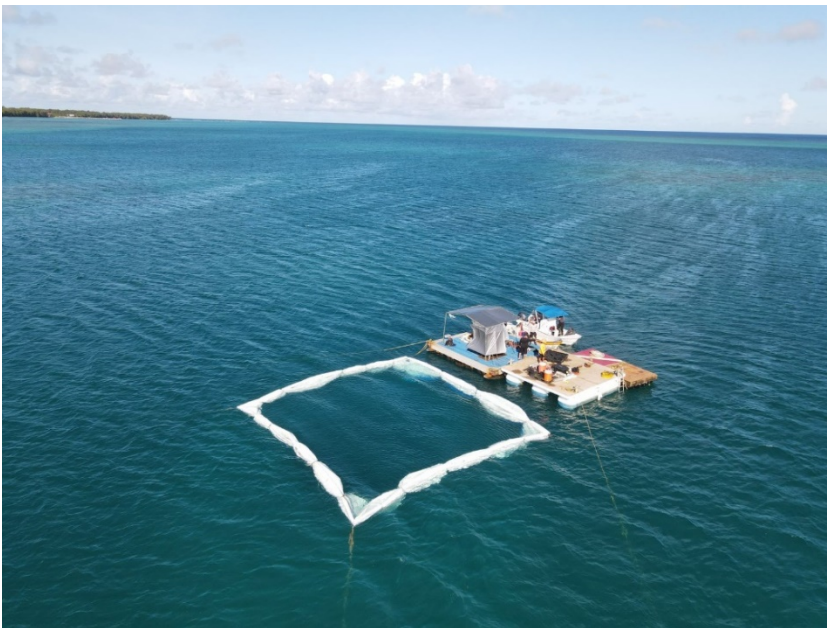
CARB Work site within Cocos Lagoon. (Photograph courtesy of Unitek).

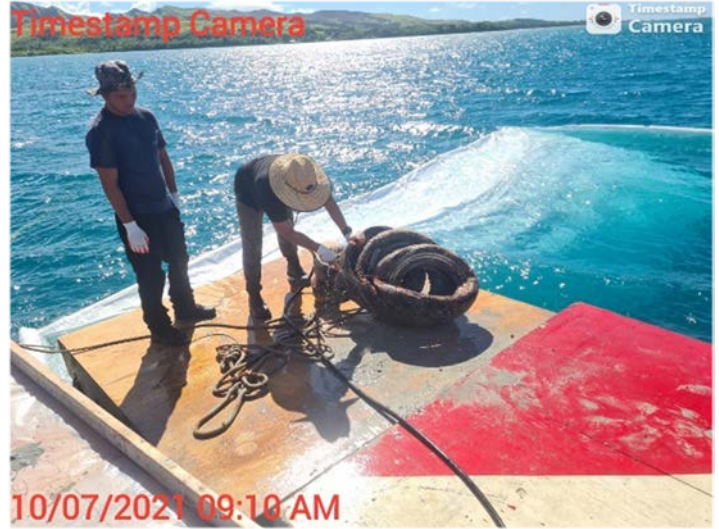
First set of tire recovered (Photograph courtesy of Unitek).

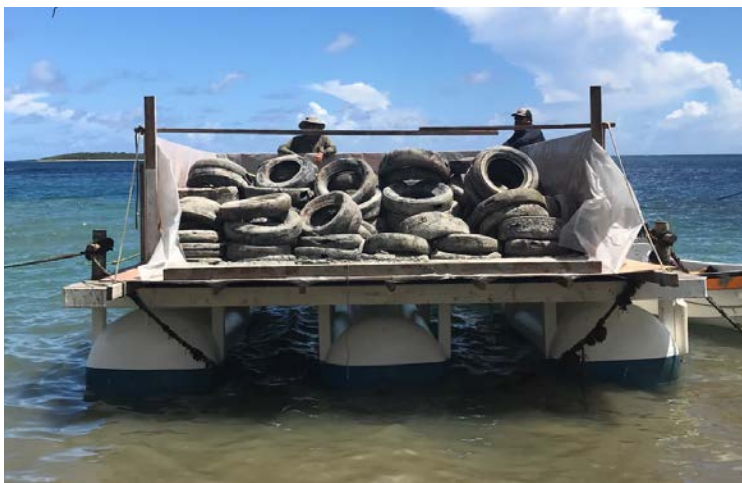
Tires being transported to shore. (Photograph courtesy of Unitek).

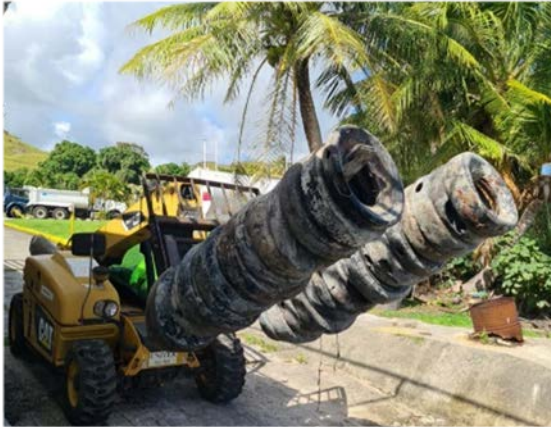
Telescopic forklift offloading Tires. (Photograph courtesy of Unitek).

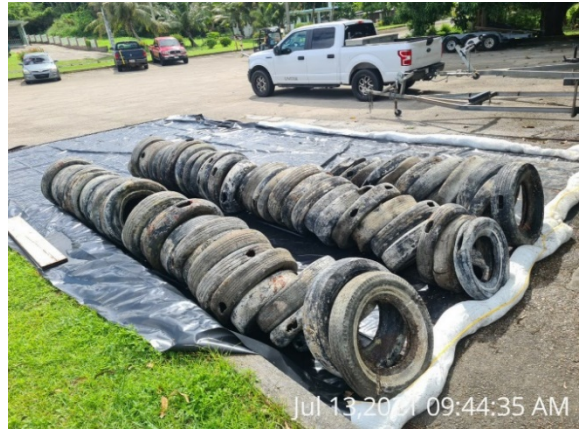
Removed Tires within temporary containment area. (Photograph courtesy of Unitek).

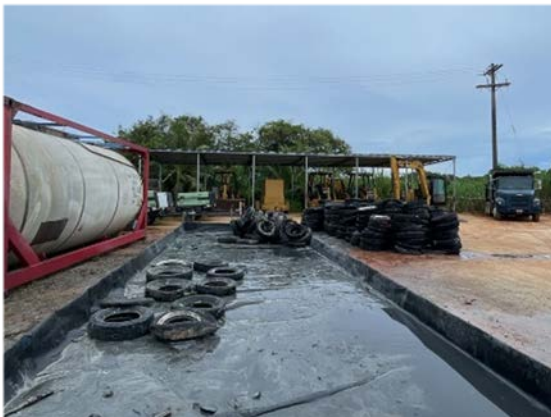
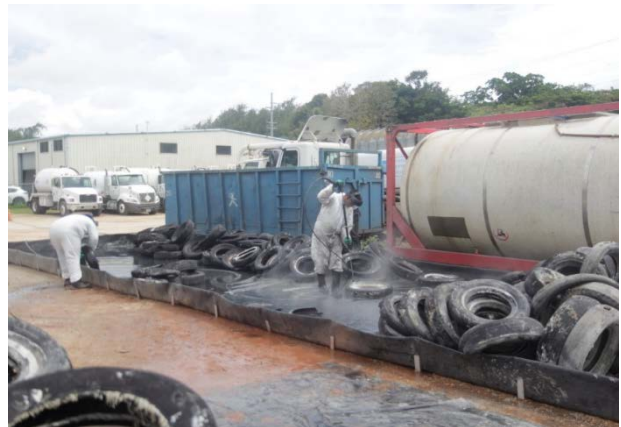
Recovered tires being cleaned and processed at the Unitek primary facility. (Photograph courtesy of Unitek).

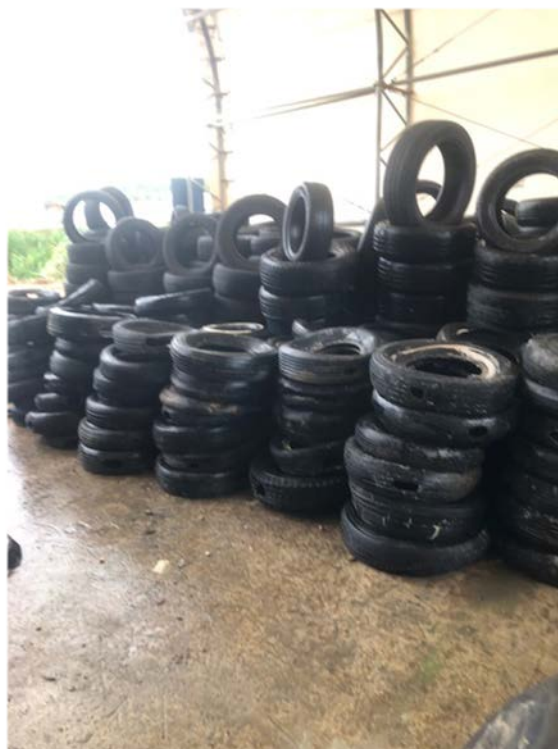
Stacked cleaned tires waiting to be shredded at the Tire Processing facility. (Photograph courtesy of Unitek).

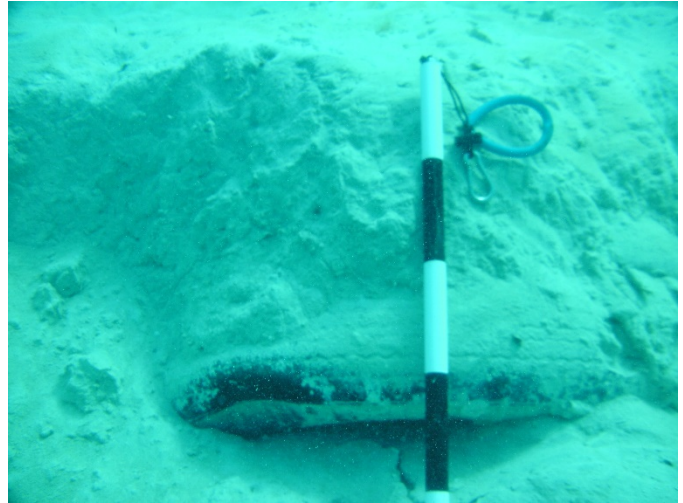
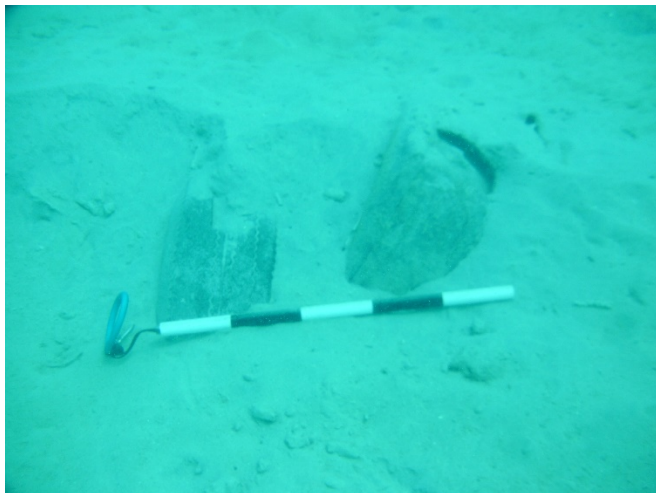
A total of one thousand eight hundred twenty-nine (1,829) or 74% of the tires were removed from the CARB site out of a reported 2,482 tires, during the sixteen (16) days of in water work. Post inspections dives were conducted by Guam EPA divers on July 30, 2021, and verified that all project objectives were met and the project was completed. During this post dive inspection, a layer of tires could be made out just under the surface or partially exposed from the removal of upper tire layers. These remaining tires (approximately 653 or CCC, buried within the

Partially exposed bottom layer of CARB not removed.
(Photograph courtesy of GEPA).

sediment were not part of the project objectives due to the high removal cost and the additional impacts from the potential resuspension of large volume of sediment. It is also anticipated that with the current sedimentation rate within Cocos lagoon that the remaining tires will be furthered buried and covered, reducing further exposure. The Government of Guam will continue to research alternative sources of funding and collaborations to remove the remaining tires at CARB and identify and locate CARA and
