PT. MOLATE BEACH PARK MARINE DEBRIS REMOVAL PROJECT

Final Project Report

Ian Wren, September 22, 2014

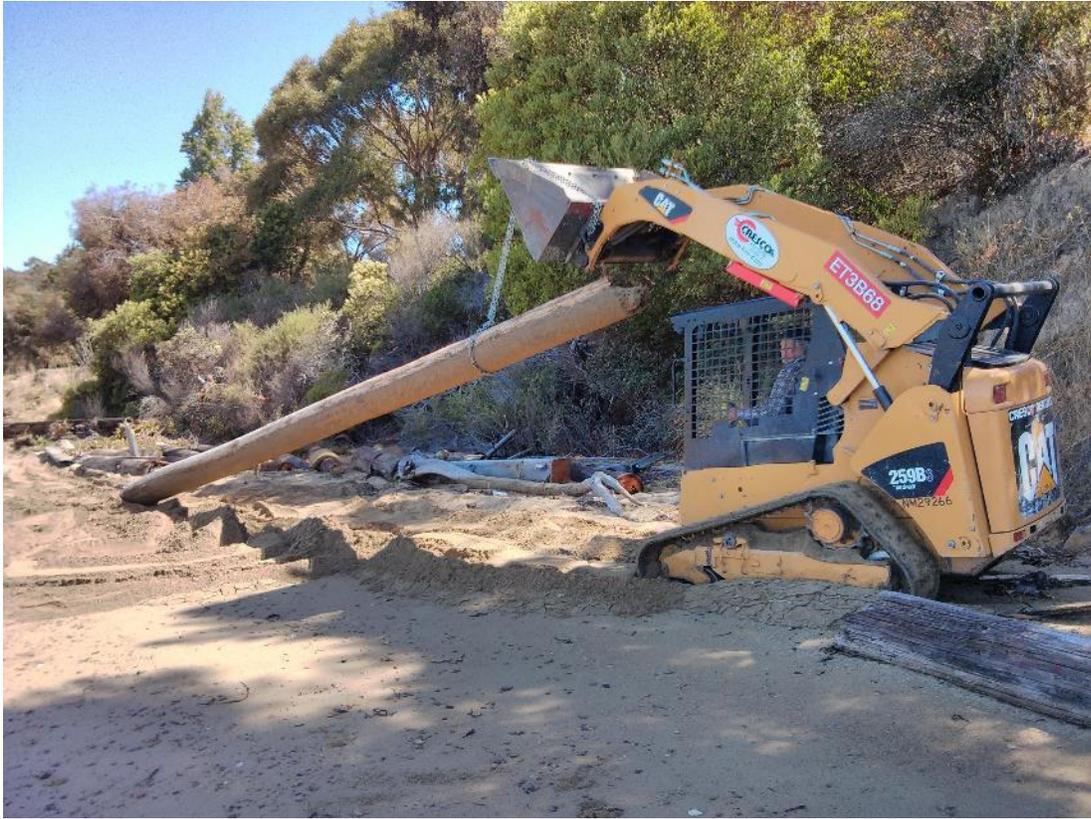
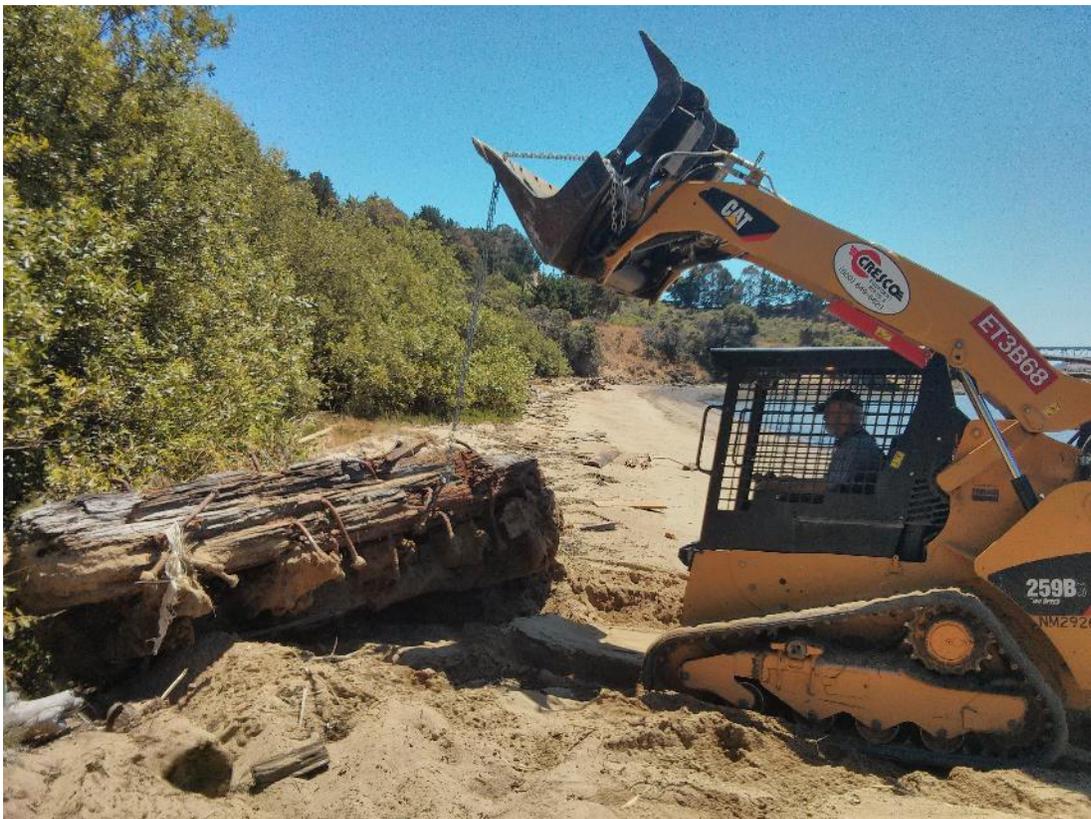
Chain used to relocate non-cresote piling for beach seating (top) and extraction of pier section (bottom)

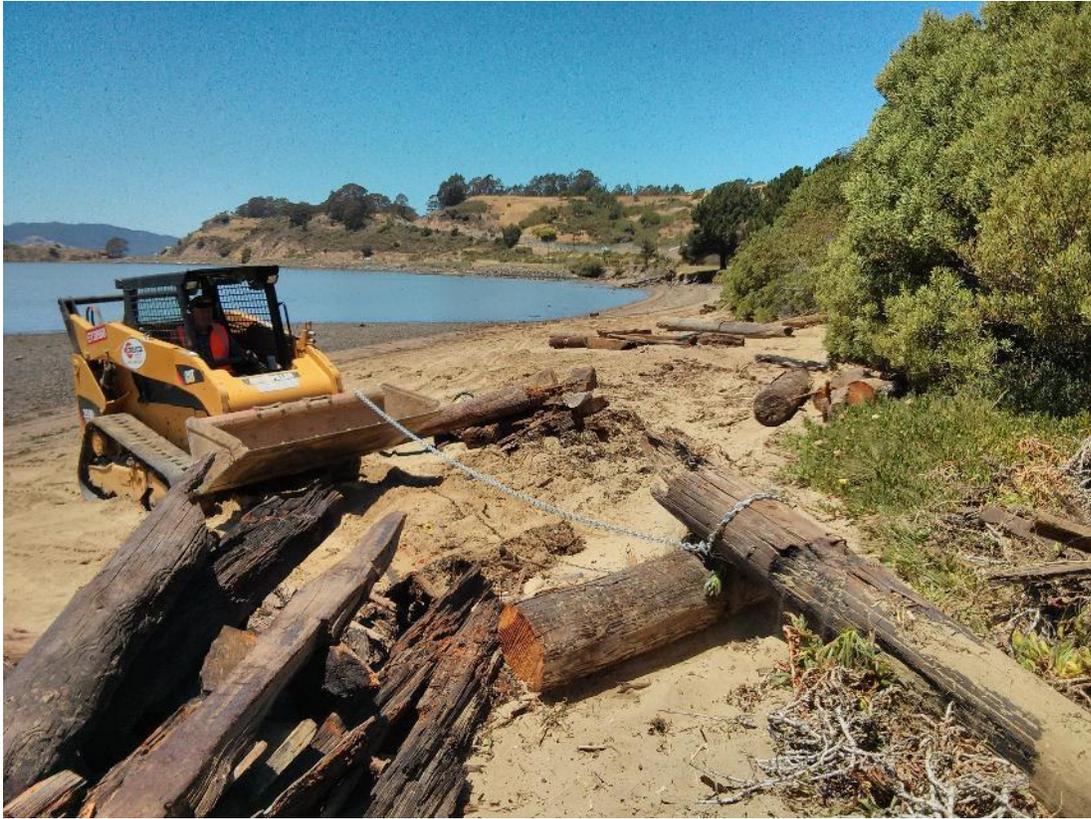
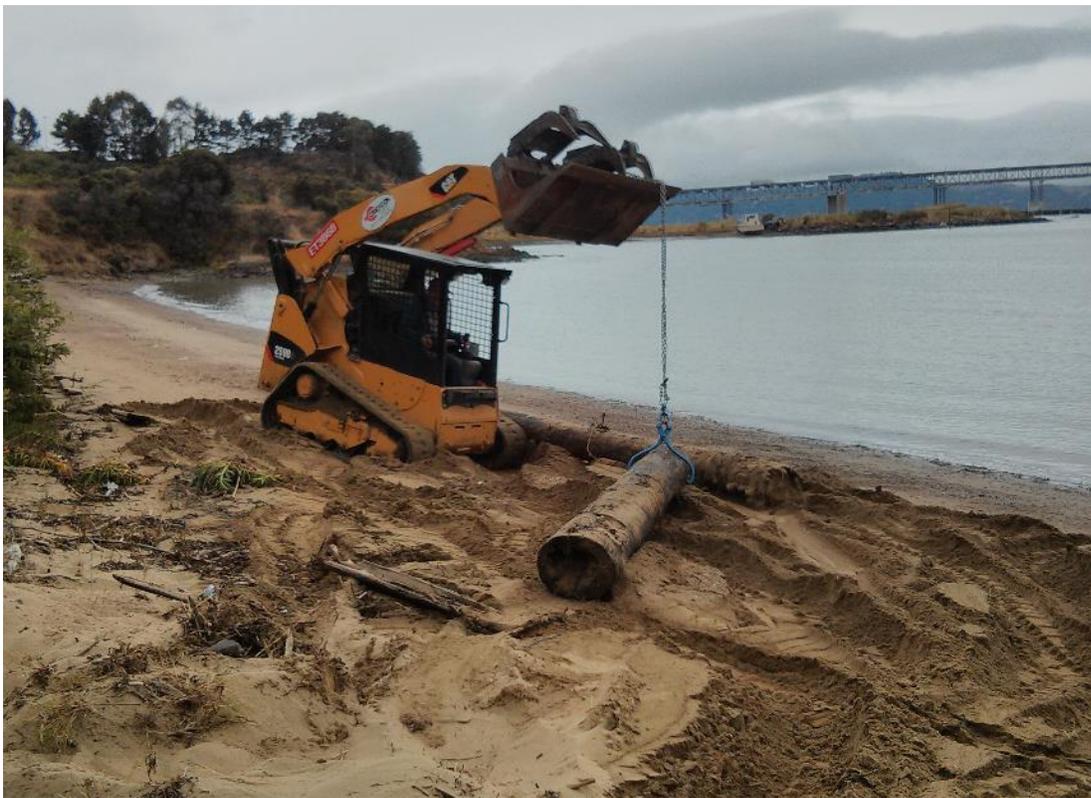
Chains and log tongs (bottom) proved useful for extracting pilings from sand and underneath bushes

After pilings were cut and material was staged on the beach a tracked skid-steer (Bobcat) was rented and delivered to the site and used over the course of three weeks in June/July 2013 and for another week in May 2014. The grapple bucket attachment worked well for extracting pilings from the sand and securing two to three pilings at a time while carried to a staging area near the parking area. The tracked skid steer worked well for the sand and was quite maneuverable. Wheeled versions would be ineffective in the soft sand. Chain and a heavy-duty log tong was used to extract buried pilings or those beneath vegetation at the edge of the beach.

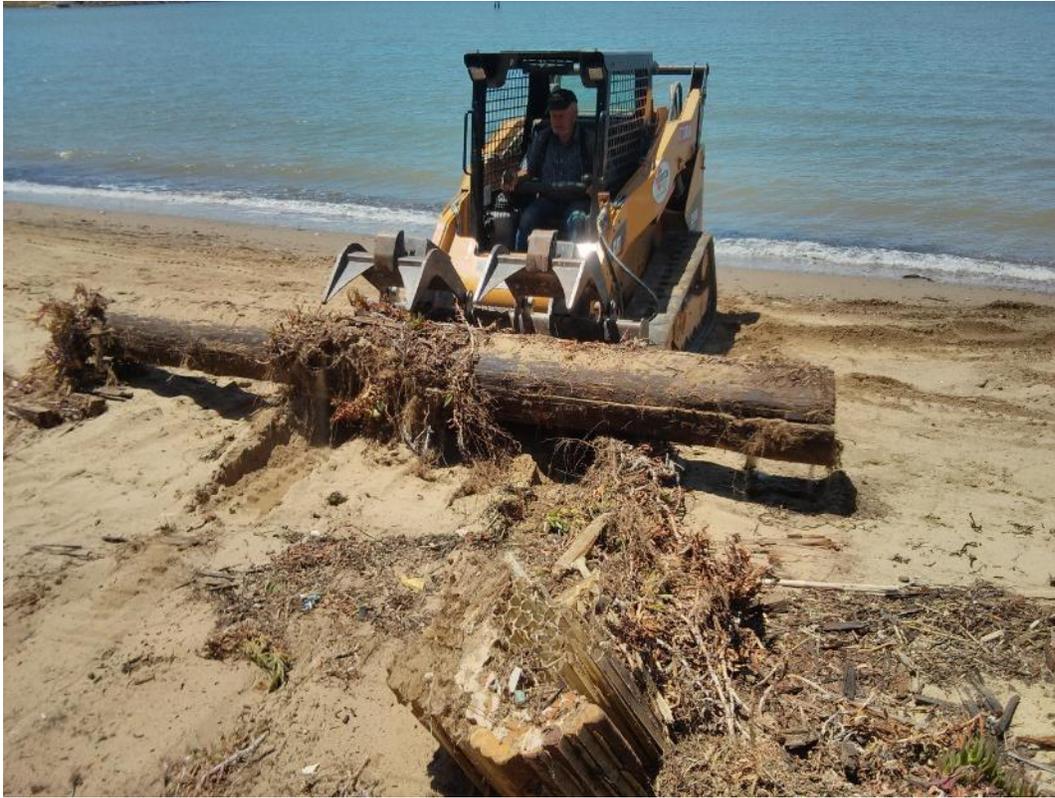
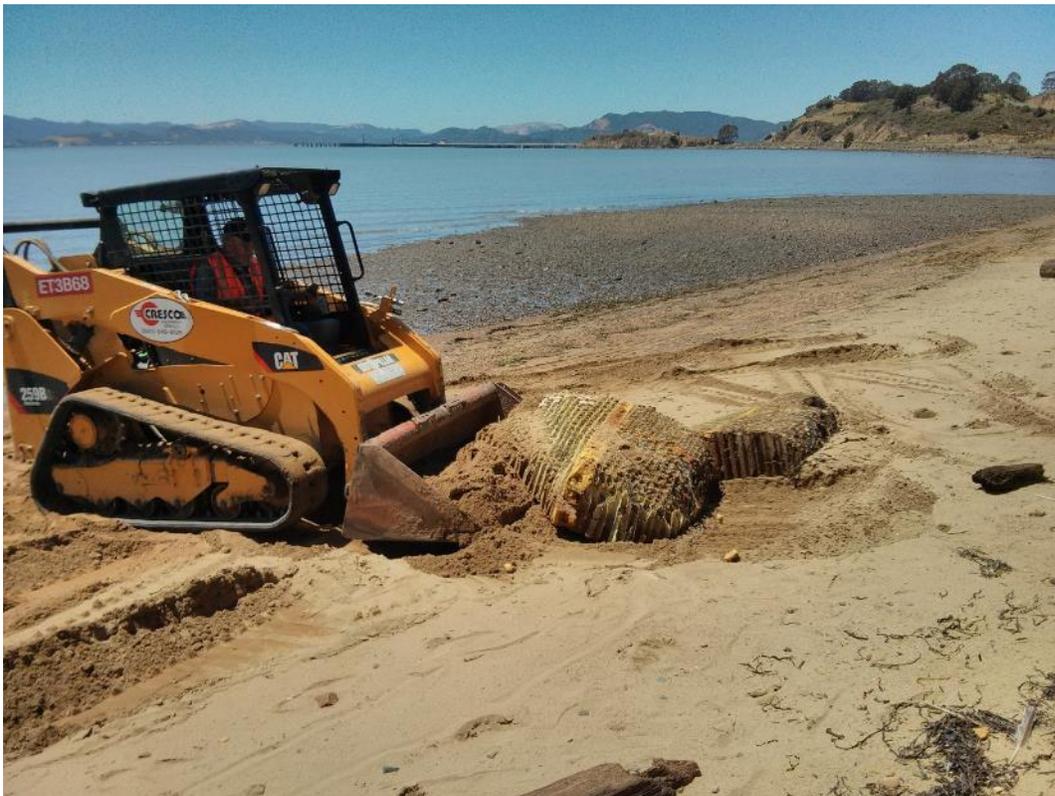
Grapple bucket for the skid steer proved invaluable for moving pilings (top). Accidental delivery of regular bucket limited the ability to move material, such as buried boat hulls (bottom).

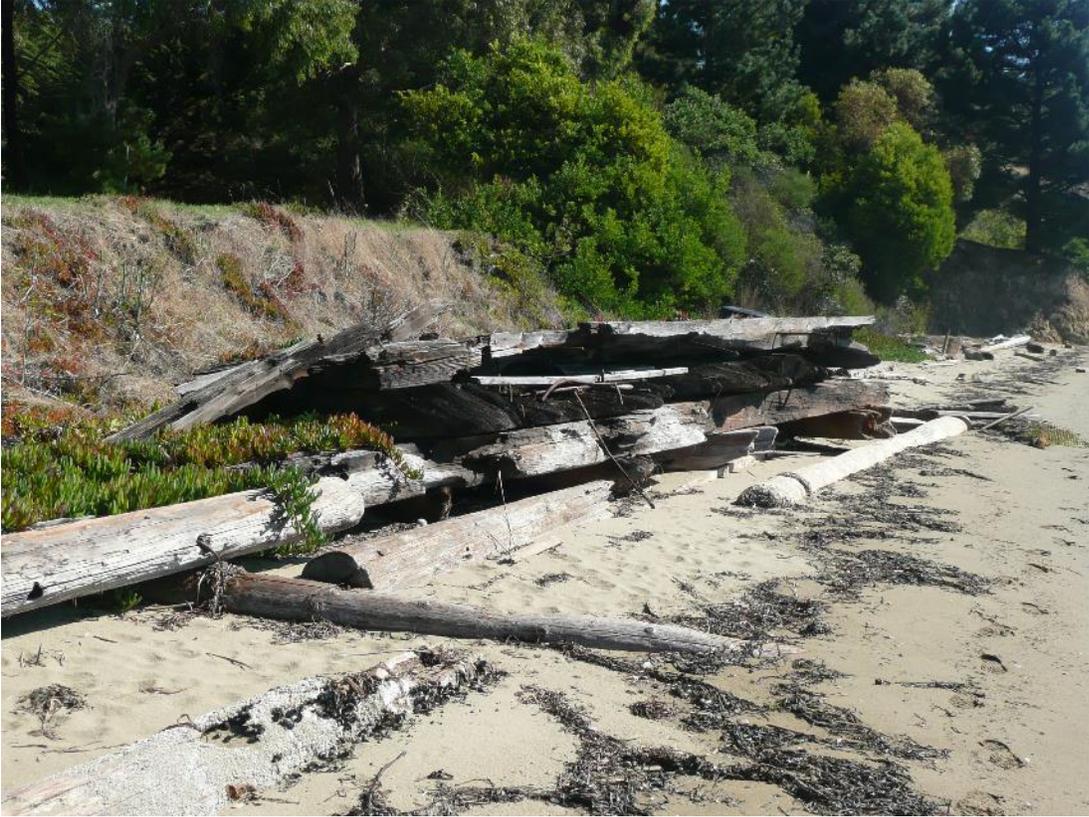
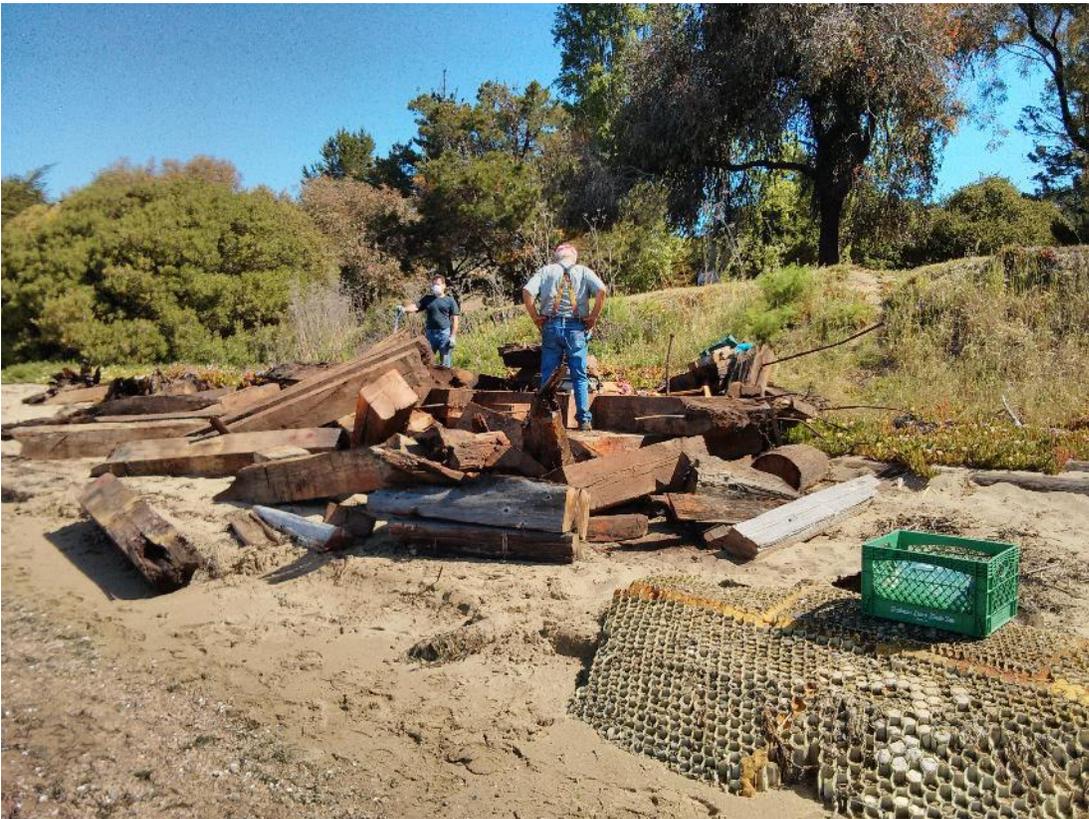
Large pier structure had to be sawed into pieces prior to removal

Piling removal was completed in phases. First, large debris found along the beach was cut into manageable sections. This included large pier sections connected by up to 6' rusted bolts that required cutting (*Appendix 2, Project Photos*). Longer pilings were cut in-situ using a cant hook with log stand and care was taken to contain creosote-contaminated saw dust. This process was laborious, as the creosote pilings quickly dulled chains and sand had to be cleared from surfaces to avoid dulling. Several volunteer work days were spent with over a dozen volunteers carrying debris to staging areas along the beach. Timber carriers were used to hand carry pilings and contaminated timbers.

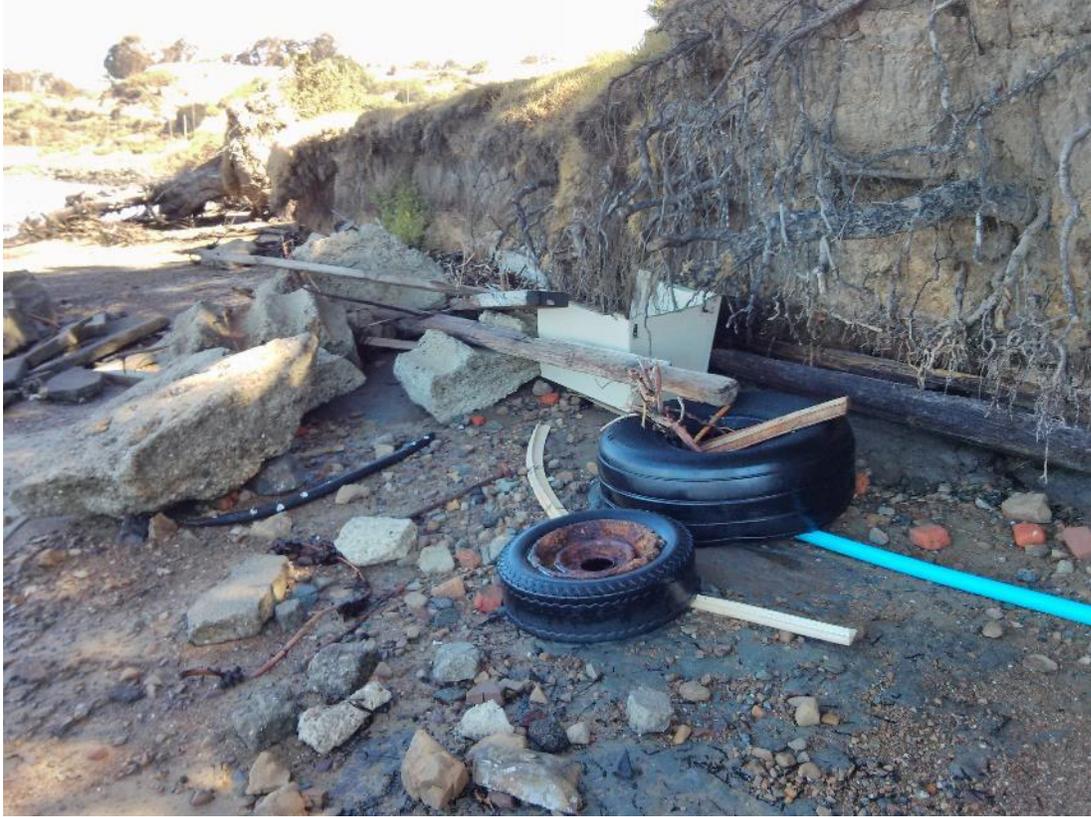
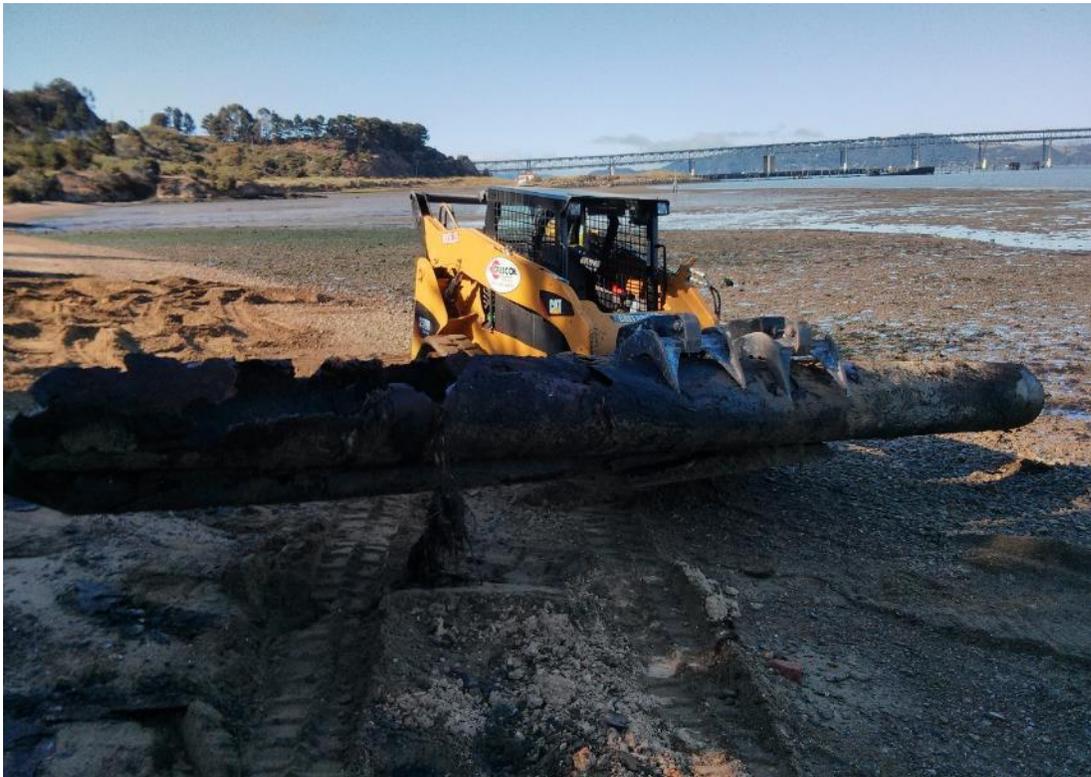
Over 20 tons of concrete was removed for recycling (top) and several large derelict rusted metal storm drain pipes were also removed (bottom)

Approximately 20 tons of concrete was removed from an area of the beach where it appeared the material had been dumped and was serving no shoreline protection purpose. The City of Richmond arranged for the pickup and recycled the material at Dutra Materials concrete recycling plant, conveniently located approximately 0.5 miles from the project site. The City also took several loads of non-contaminated waste to the West Contra Costa landfill, including pier sections that had landed on the beach, boat hulls, derelict pipes, etc.

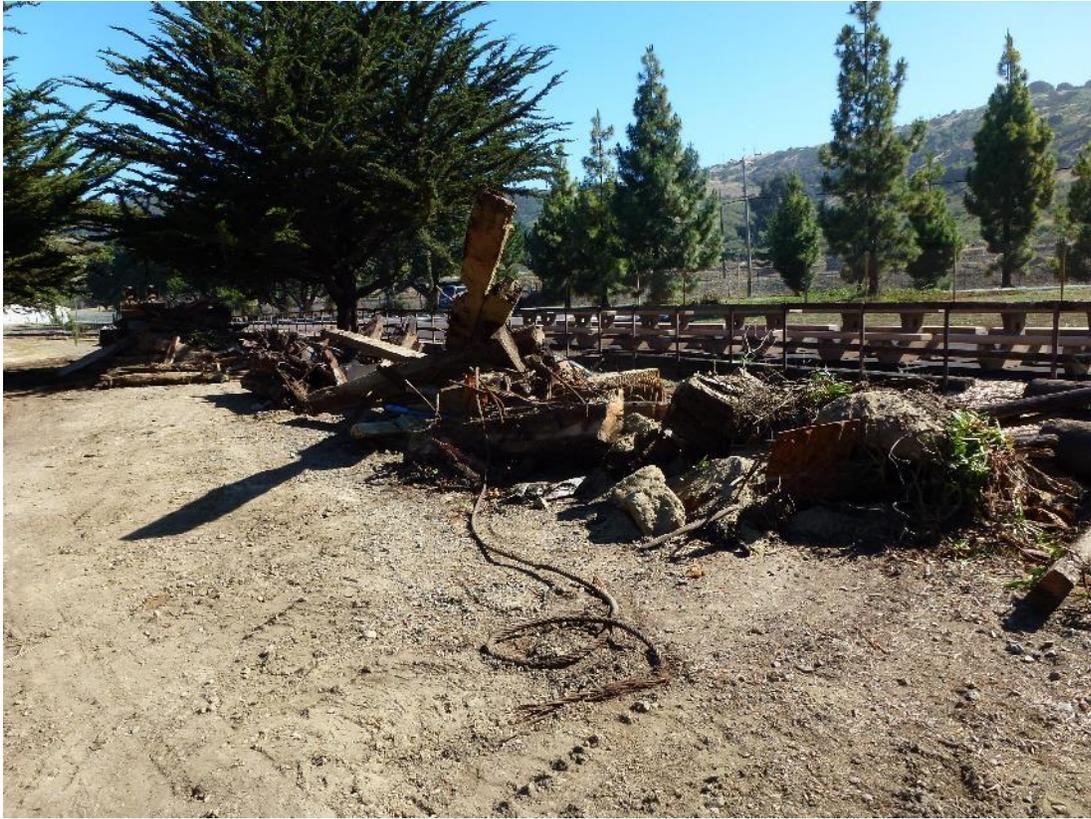
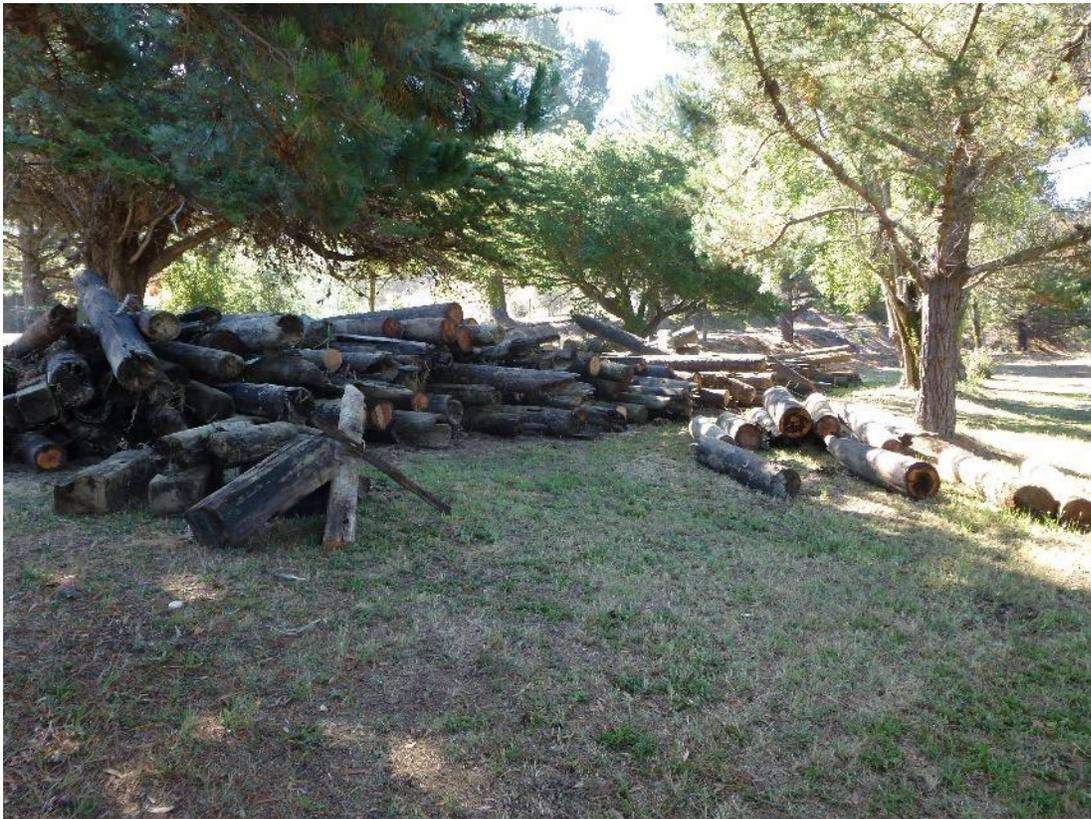
Sample view of piles of creosote pilings and other debris

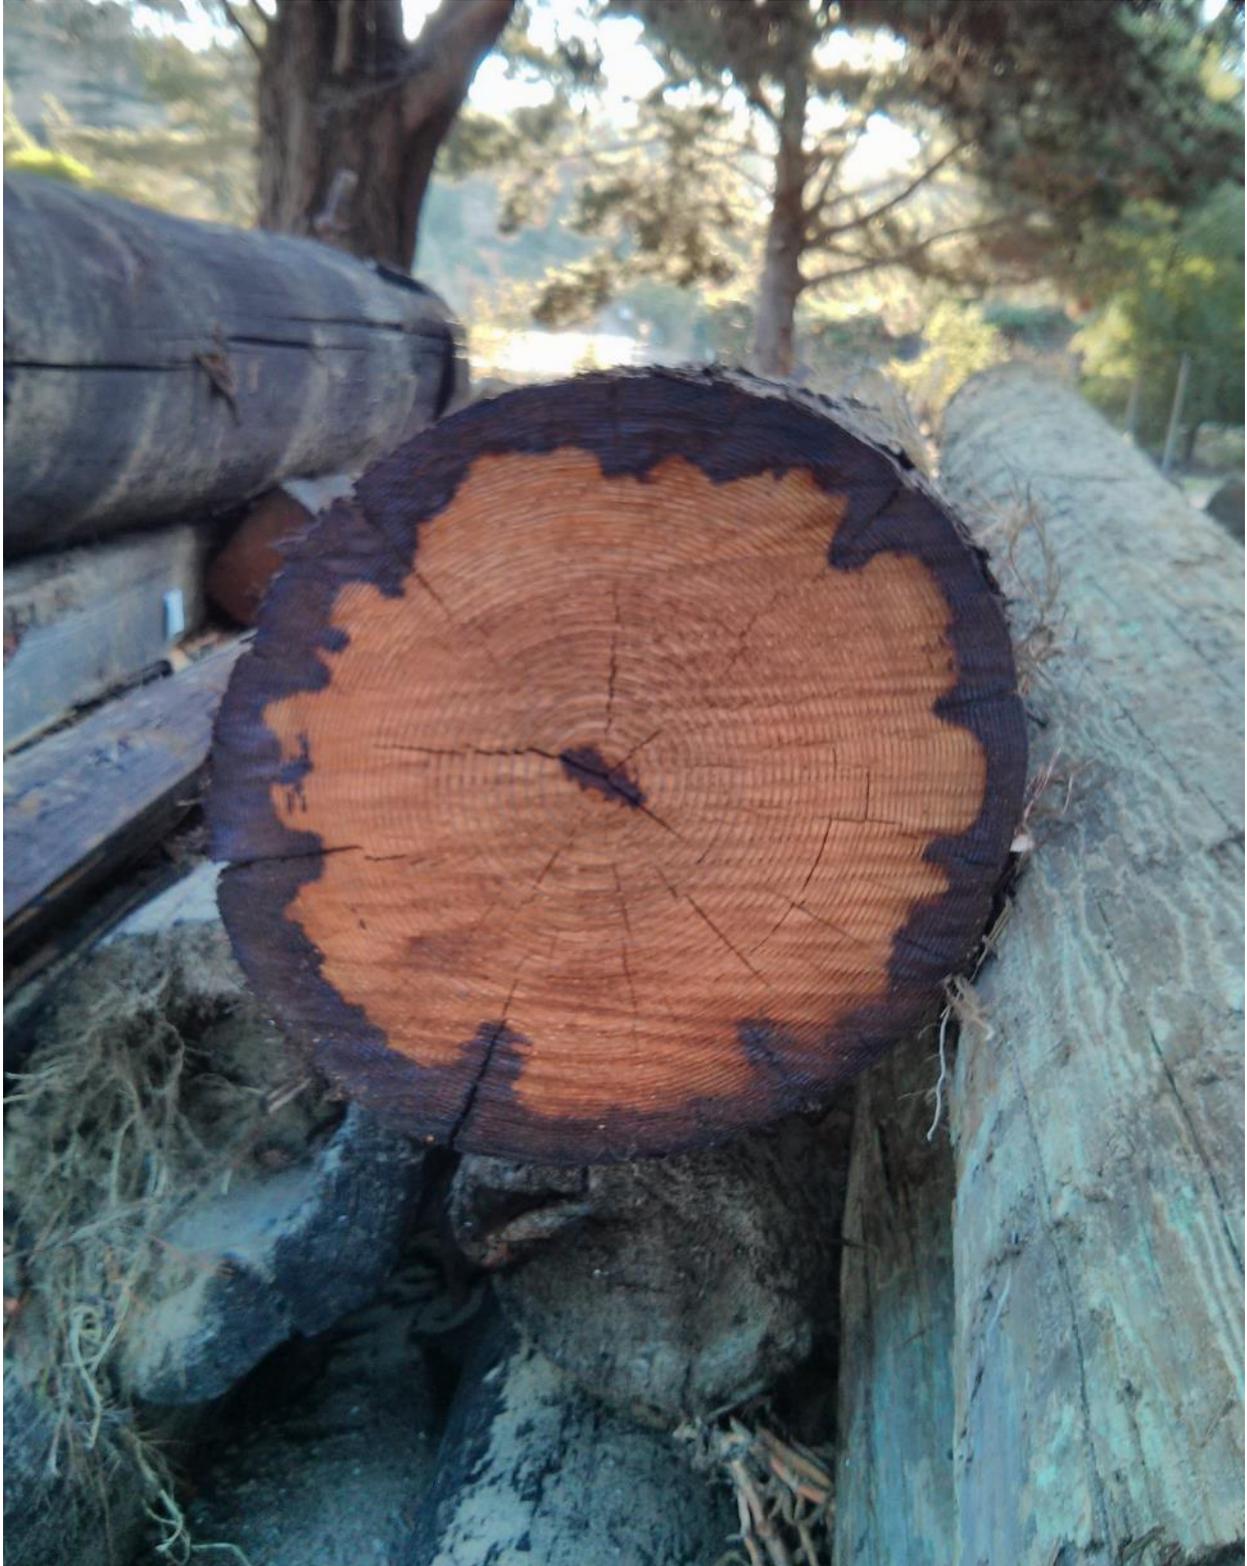
Many pilings had to be cut to optimize placement in the debris bins. Sample view of cut creosote piling, showing creosote on the outer edge. On hot days piles of creosote pilings released odors strong enough to prompt public complaints prior to removal.

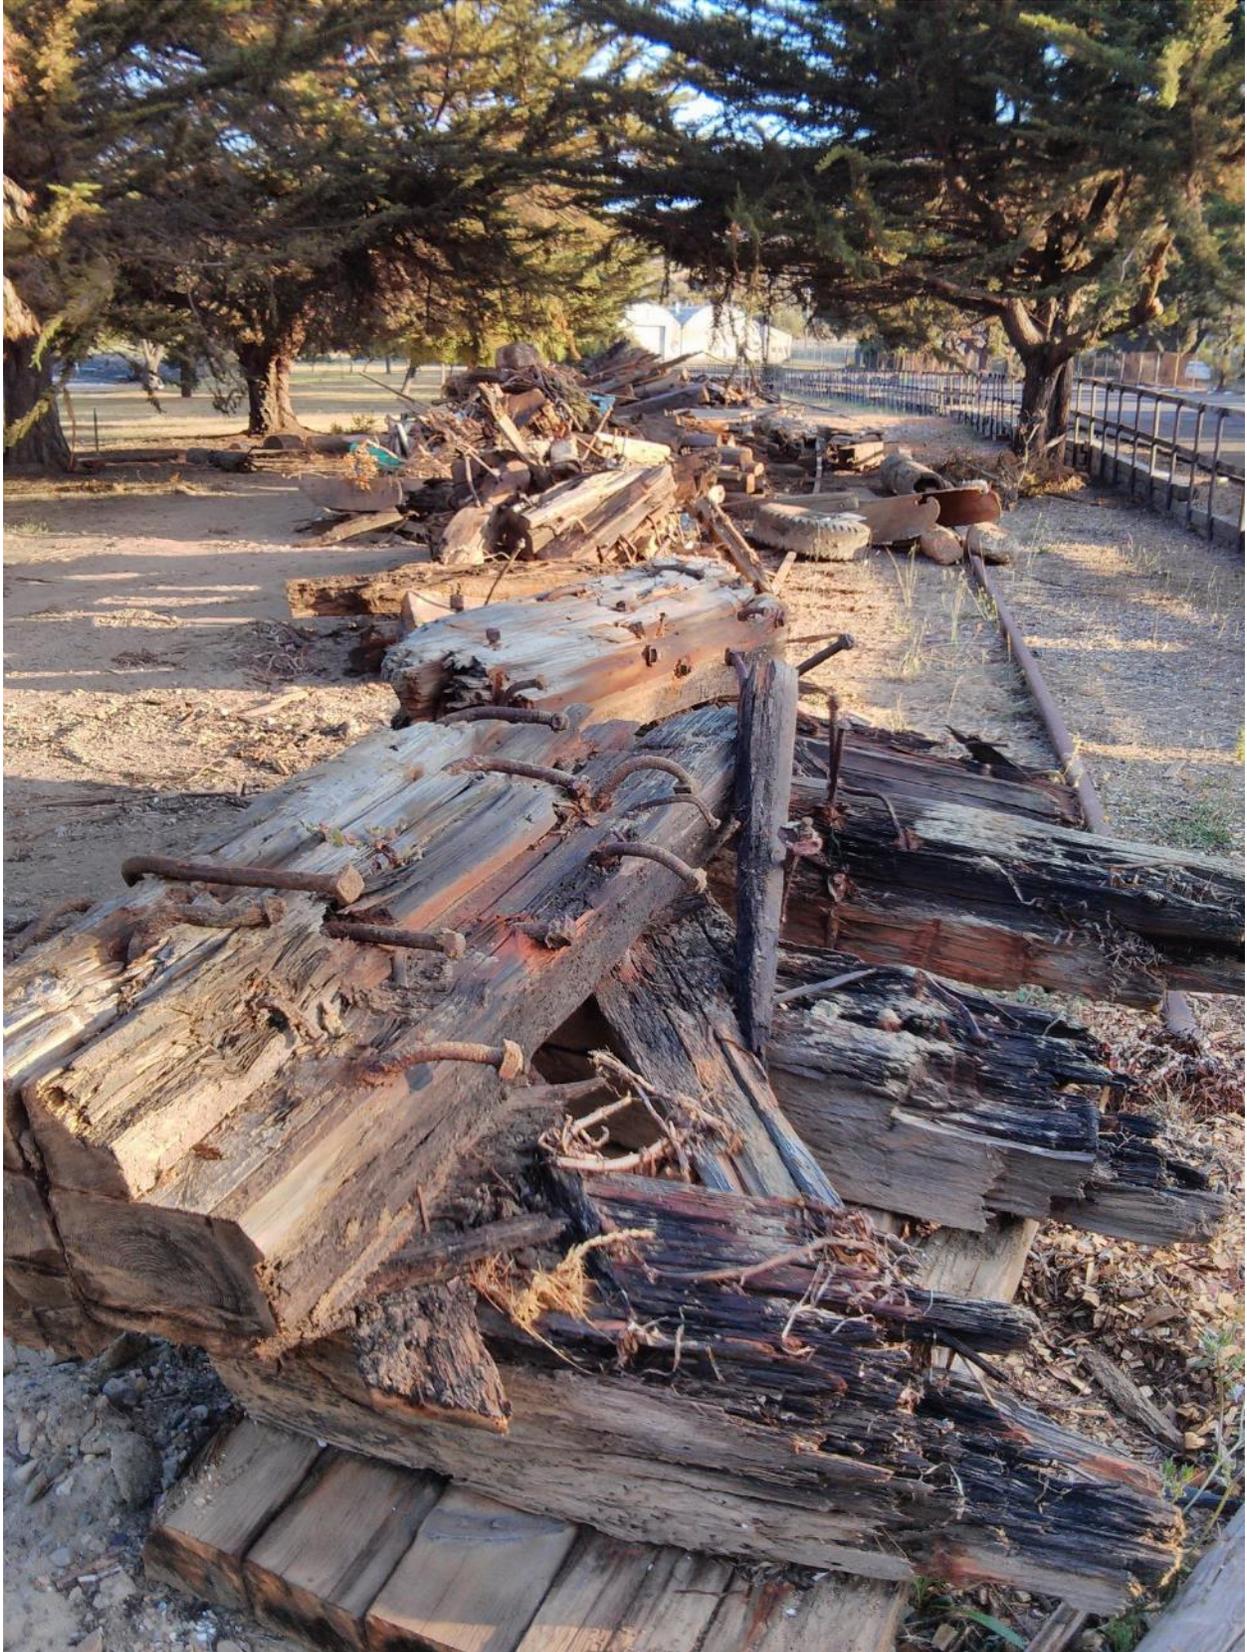
Several large pier fragments, such as this, were removed from the beach

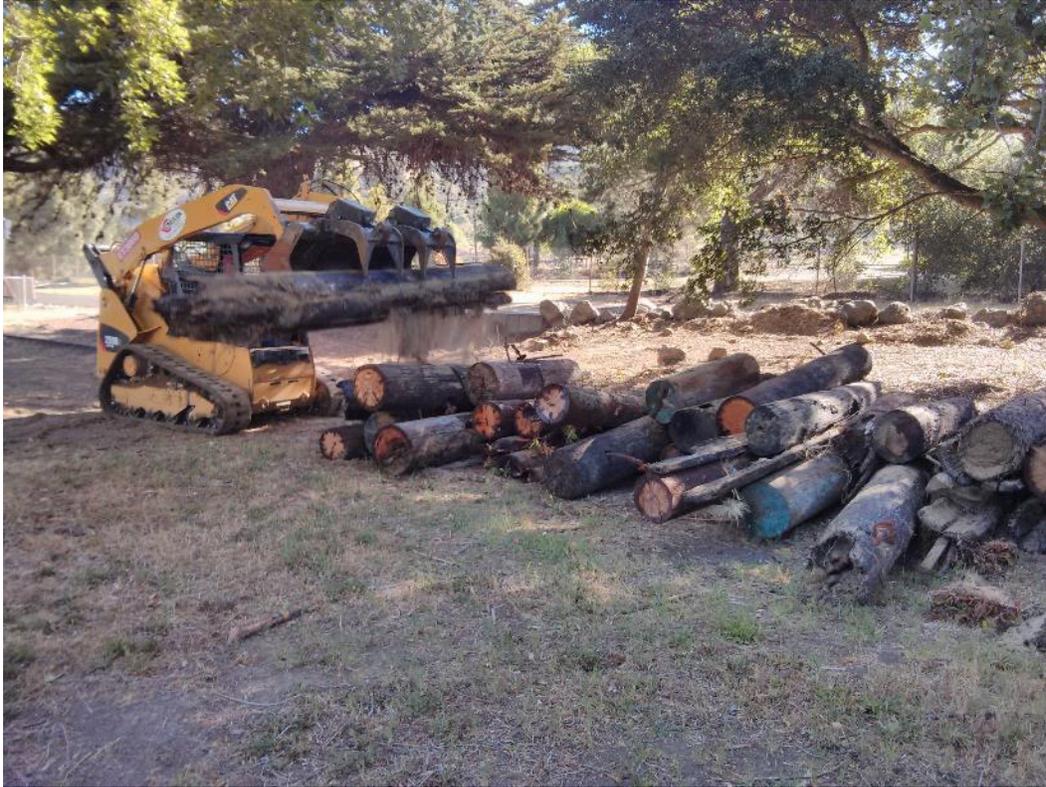
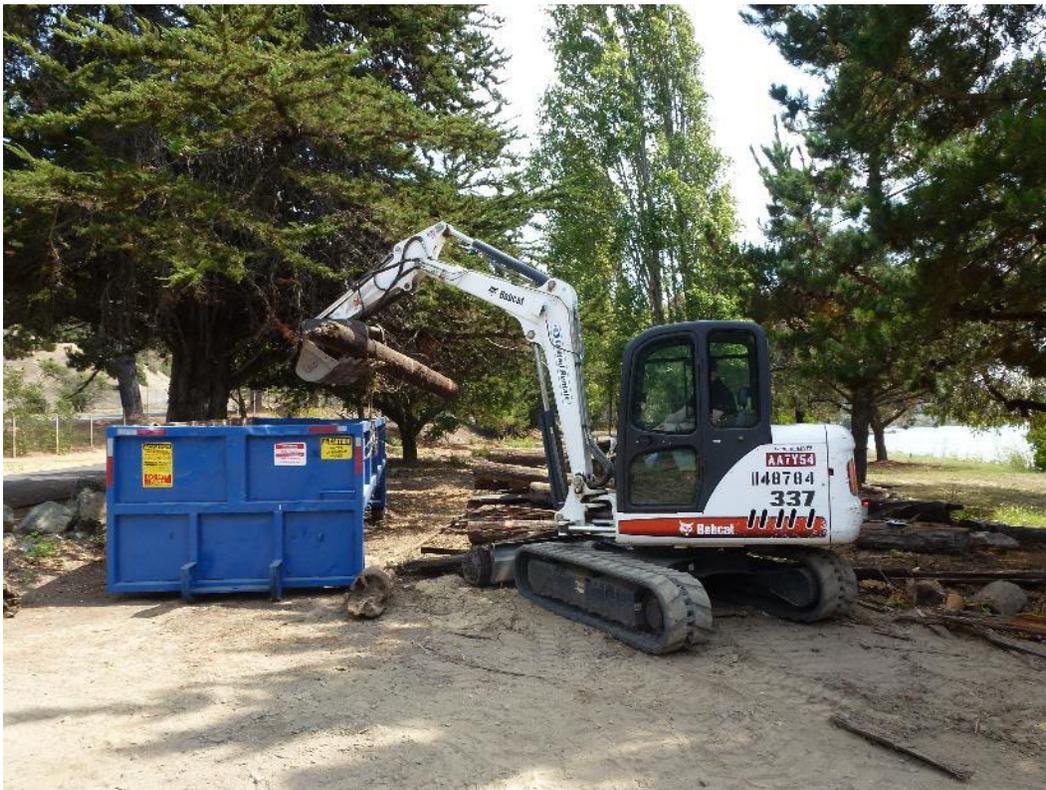
Cresote pilings were stacked in staging areas with a skid steer prior to loading into debris bins with a mini-excavator

Material was stacked by the categories generally represented in Table 1, to facilitate appropriate disposal. After sufficient material was stockpiled a mini-excavator was rented to place the pilings into 30-yard

debris bins. This size was considered the maximum allowable bin size, based on the expected weight of the pilings. The mini-excavator allowed for placement and organization of material in the bin, which was not possible with the skid-steer. Richmond Sanitary is equipped to handle non-contaminated waste, for disposal at to the West Contra Costa Landfill in Richmond, CA, or special waste, such as treated wood, destined for Keller Canyon Landfill in Bay Point, CA. Each bin required containing treated wood required a manifest and extensive coordination with the special waste manager was required, since this was apparently a somewhat rare disposal scenario. Filled debris bins averaged ~7 tons, based on receipts provided by the landfill.

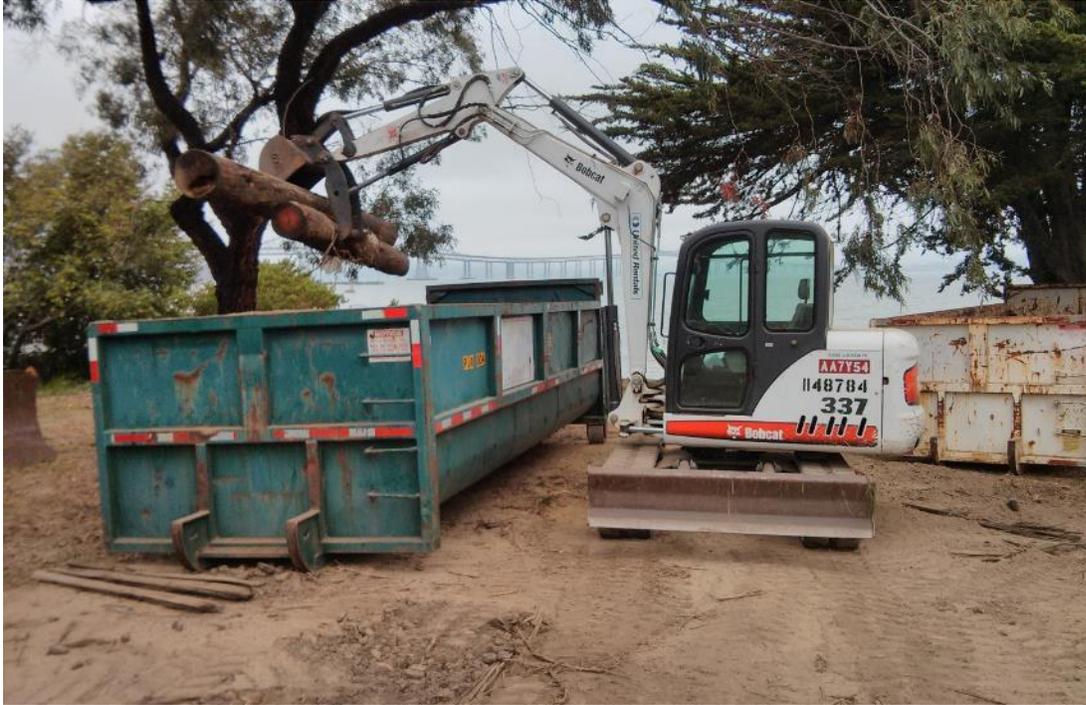
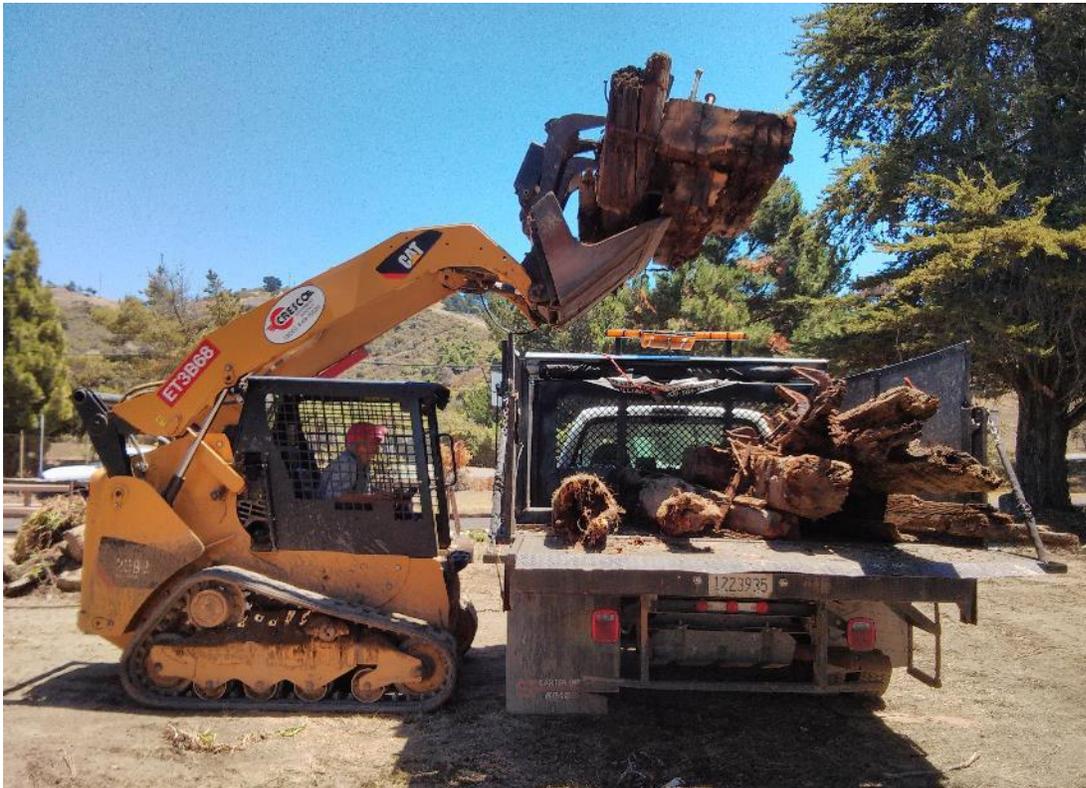
Twelve (12) 30-yard debris bins were delivered and filled primarily with creosote pilings for disposal at Keller Landfill (top). The City of Richmond delivered eight (8) truckloads of non-contaminated wood, concrete and tires to the Richmond landfill and a nearby concrete recycling facility (bottom).

Debris was removed in twelve (12) 30-yard debris bins, as well as trucks operated by the City of Richmond, which disposed of non-contaminated waste to the West Contra Costa Sanitary Landfill and the nearby Dutra Materials concrete recycling plant. The City of Richmond transported eight (8) loads to the landfill and recycling plant.

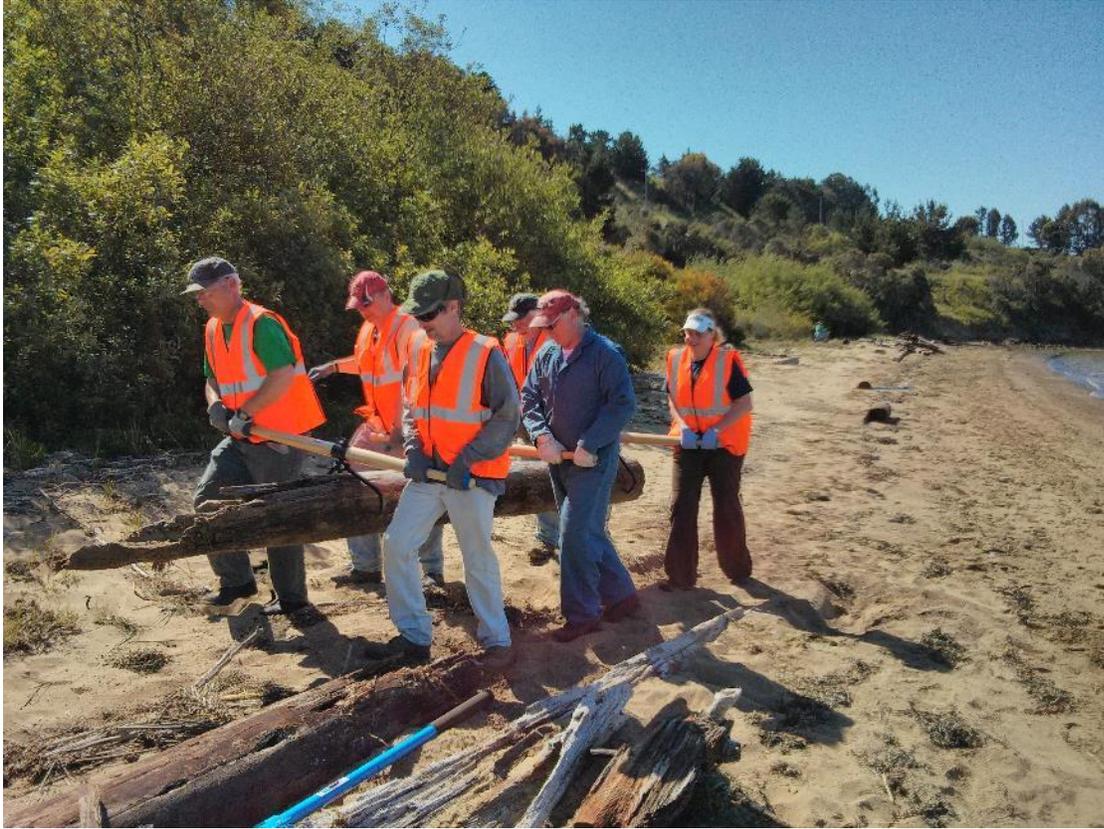
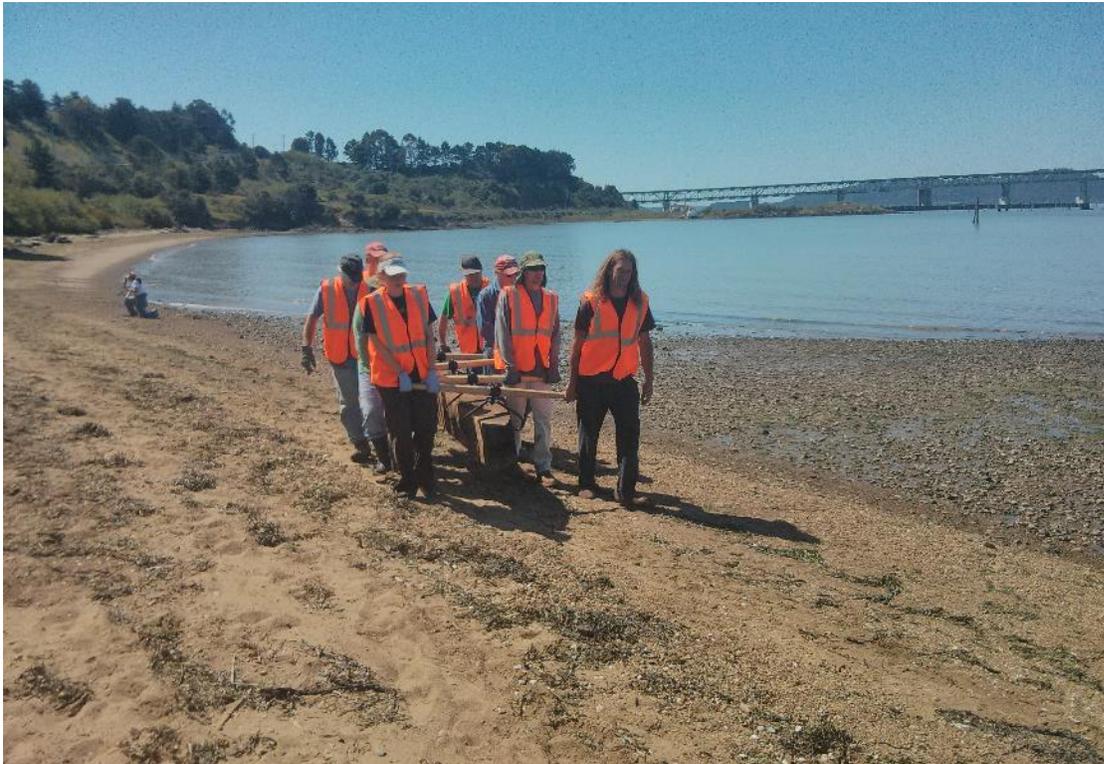
Volunteers using timber carriers to move pilings. Cant hooks (4') were helpful to extract pilings from the sand

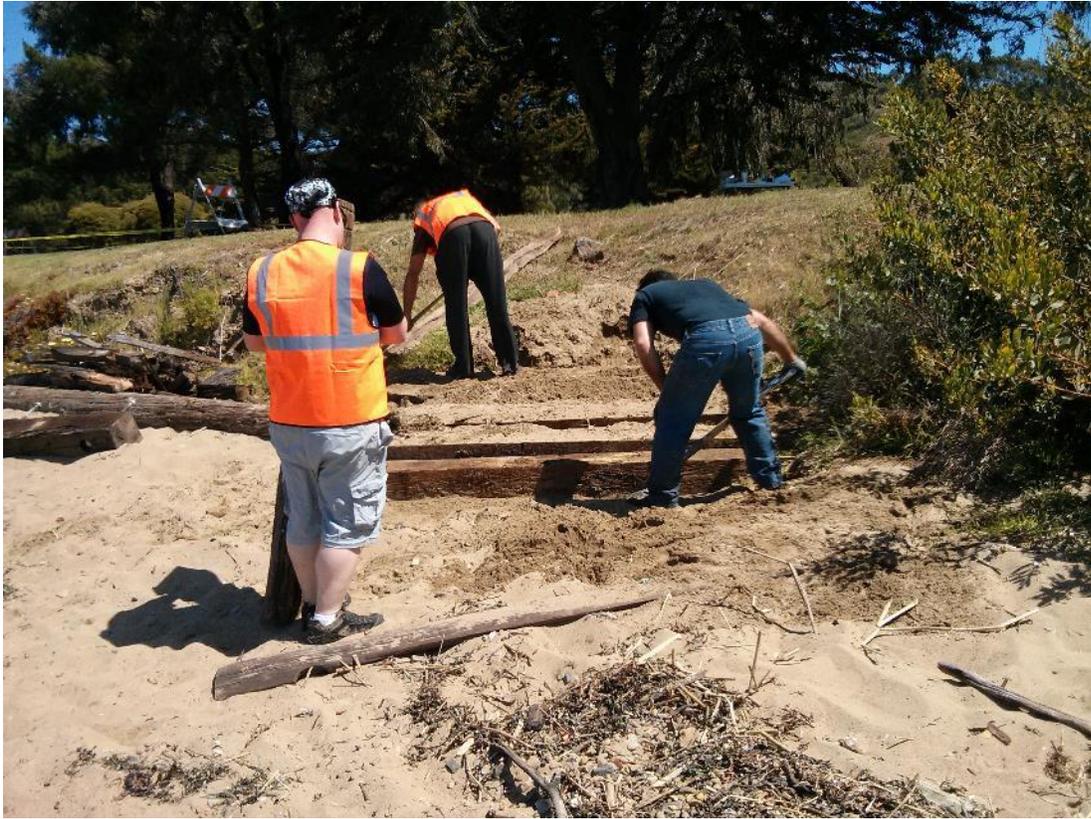
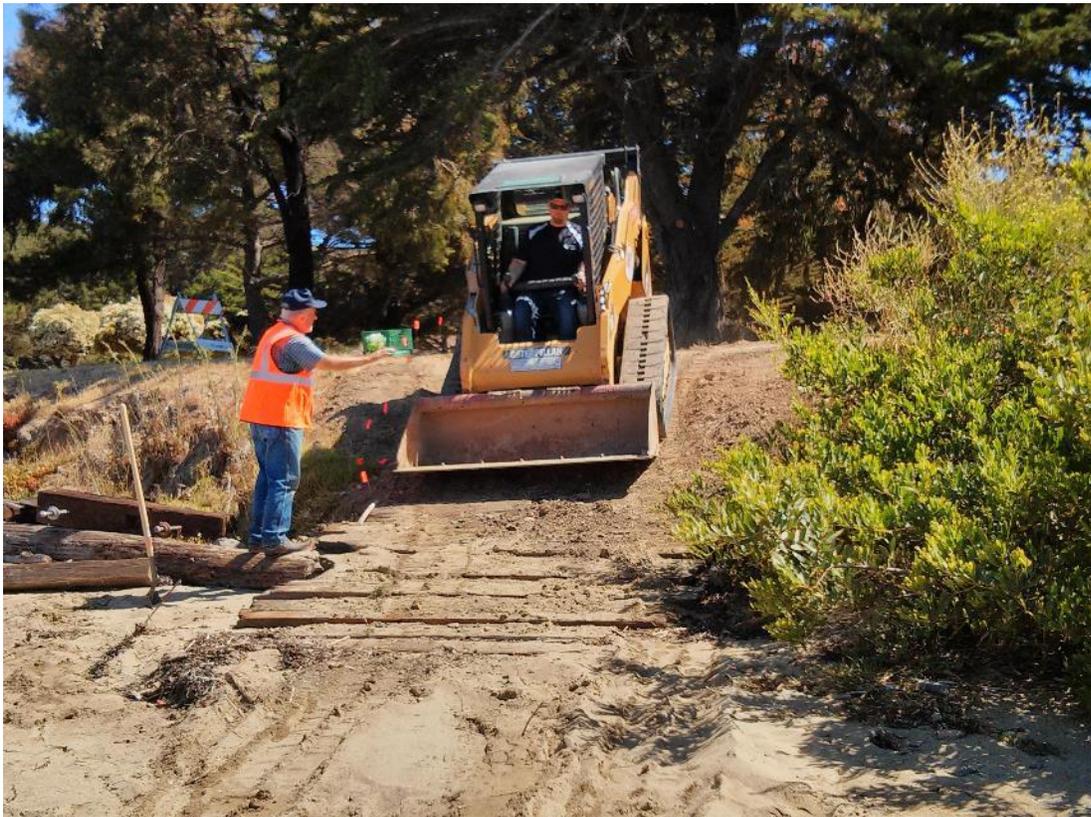
Volunteers constructing a ramp (Top) to enable skid steer access at the only available access point
