PT. MOLATE BEACH PARK MARINE DEBRIS REMOVAL PROJECT

Final Project Report

Ian Wren, September 22, 2014

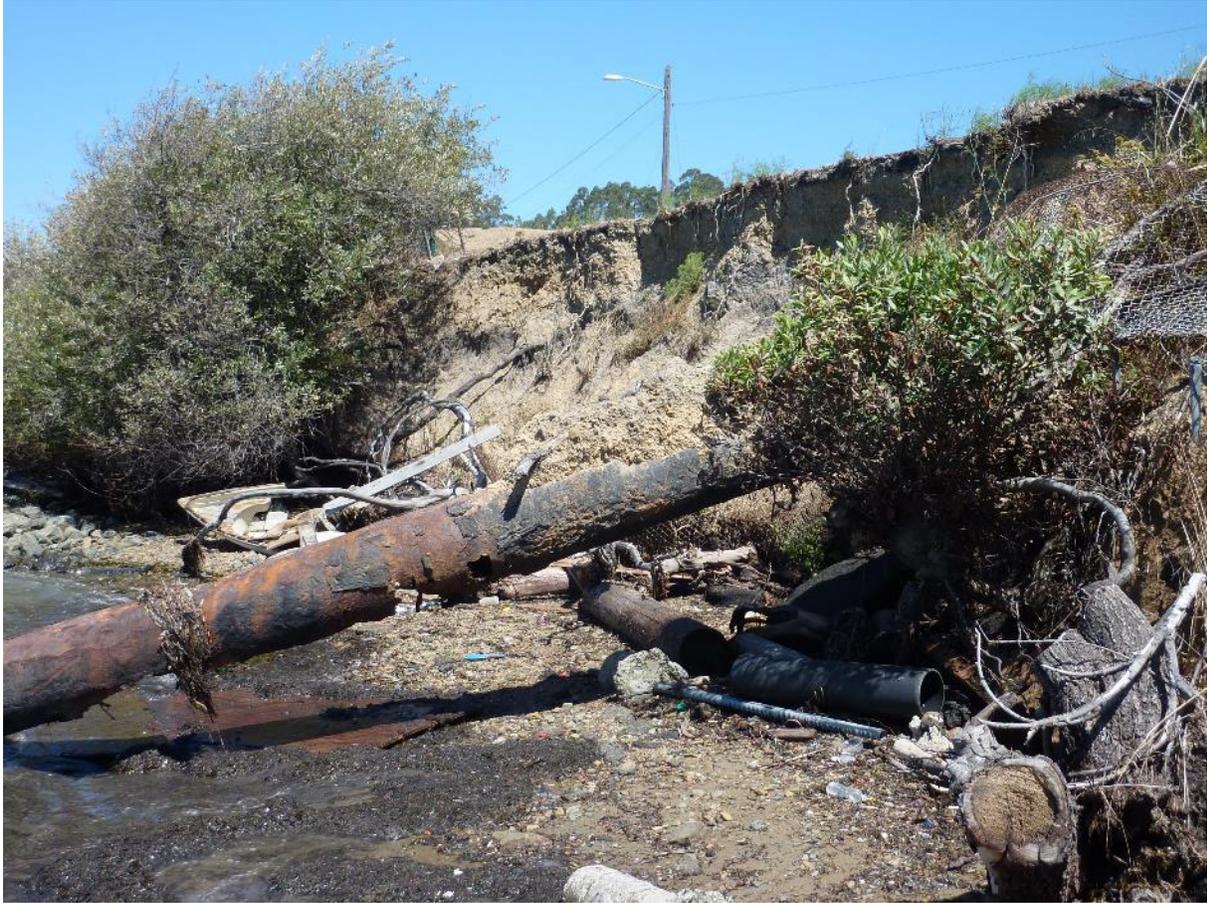
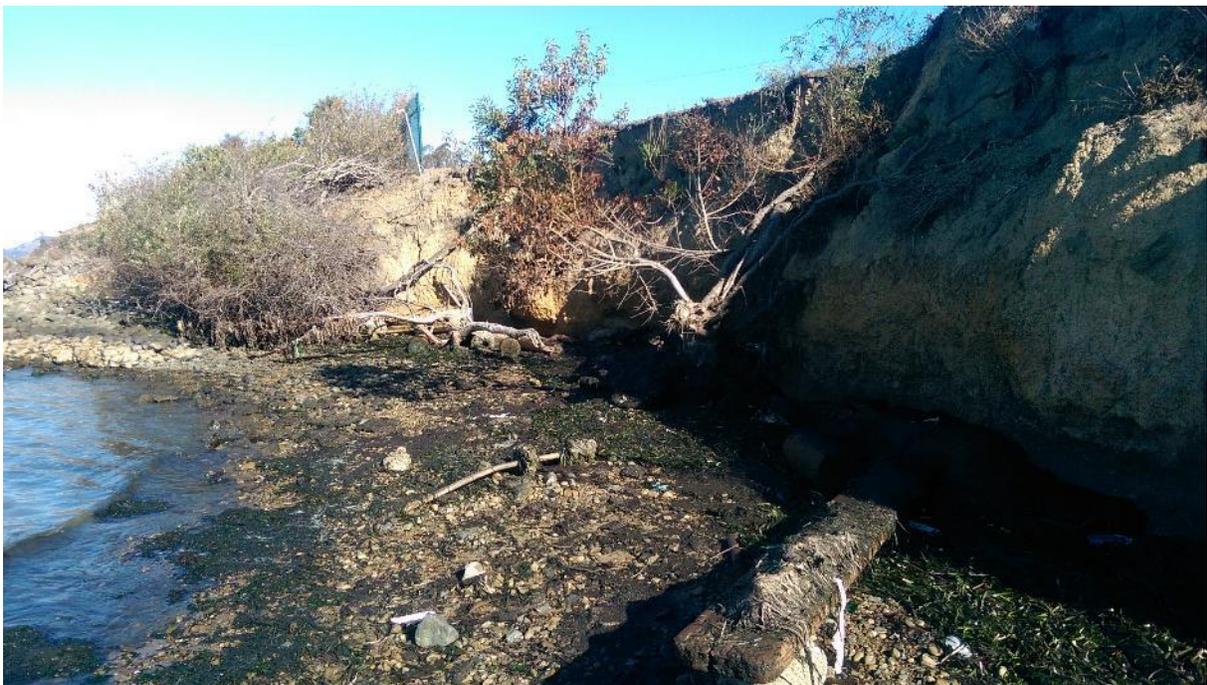
Before – 2012 (top) and after – 2014 (bottom). Small boat, metal pipes, pilings and collapsed fence removed

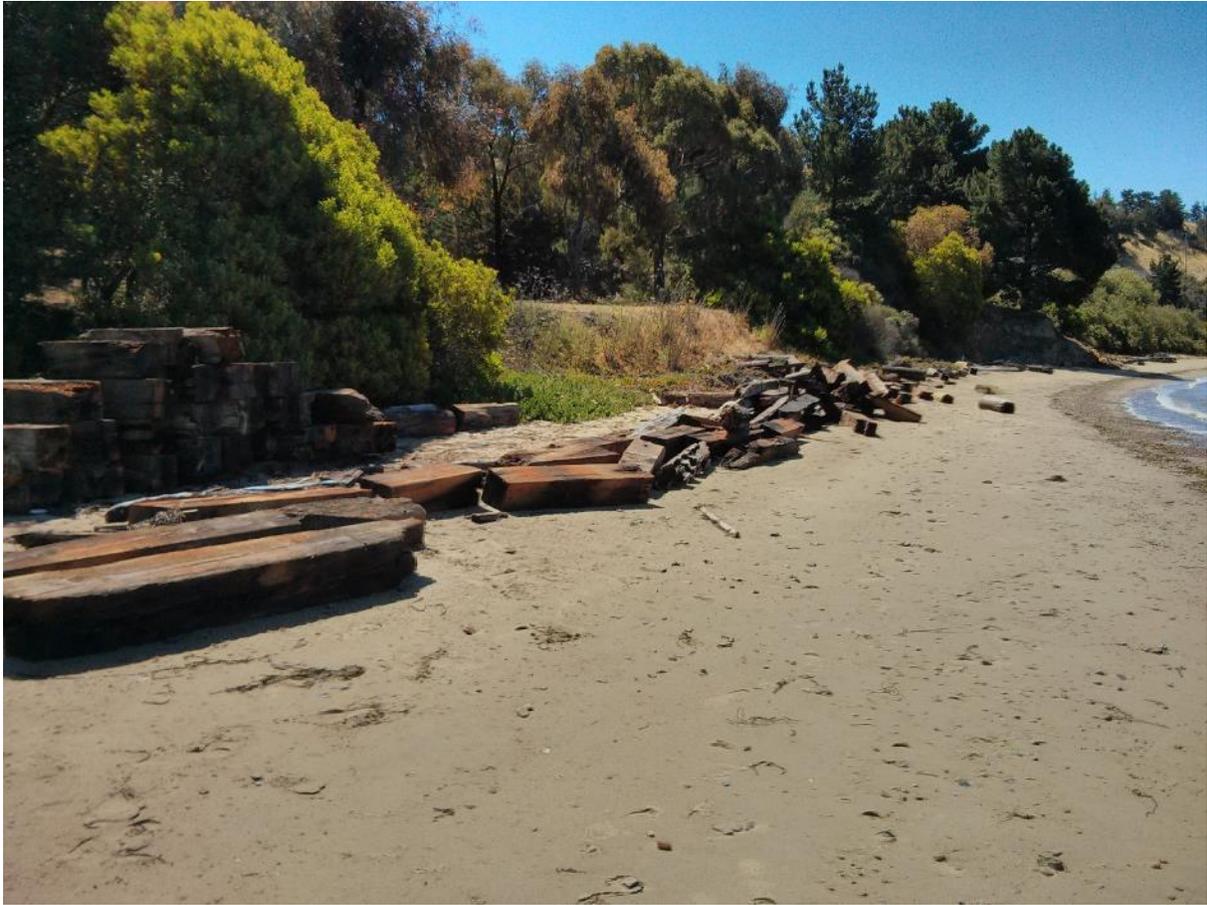
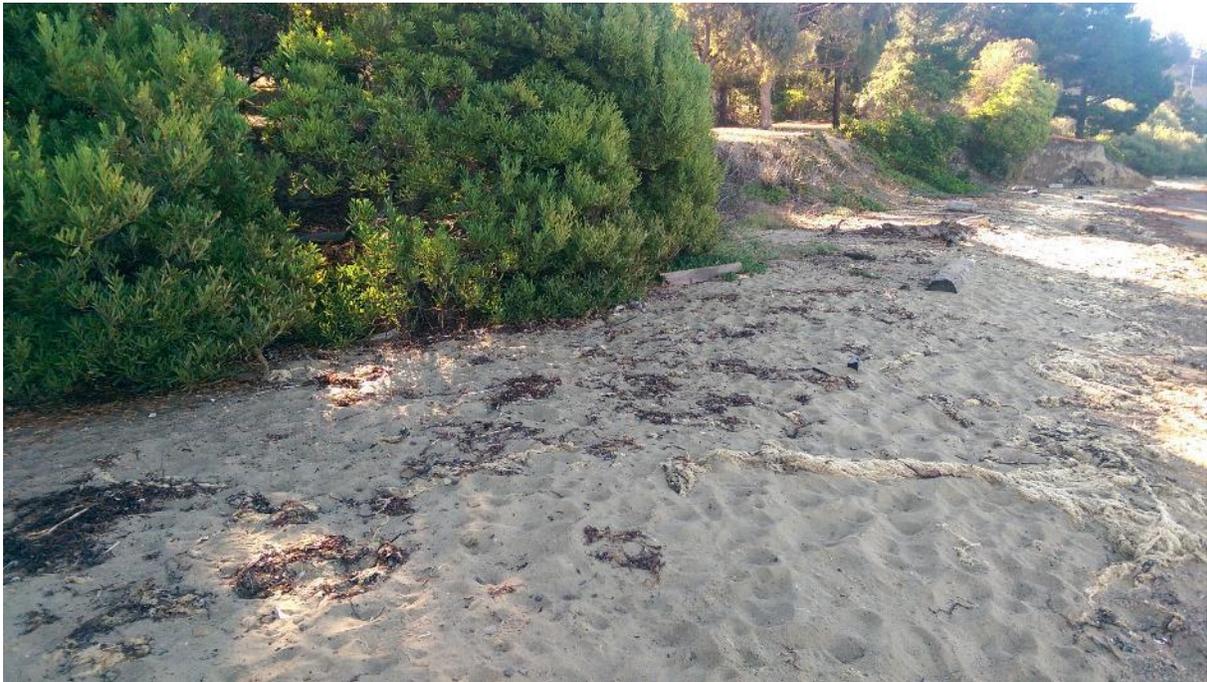
Before – 2013 (top) and after – 2014 (bottom) Timbers shown above were from the large pier section that required extensive sawing prior to removal.

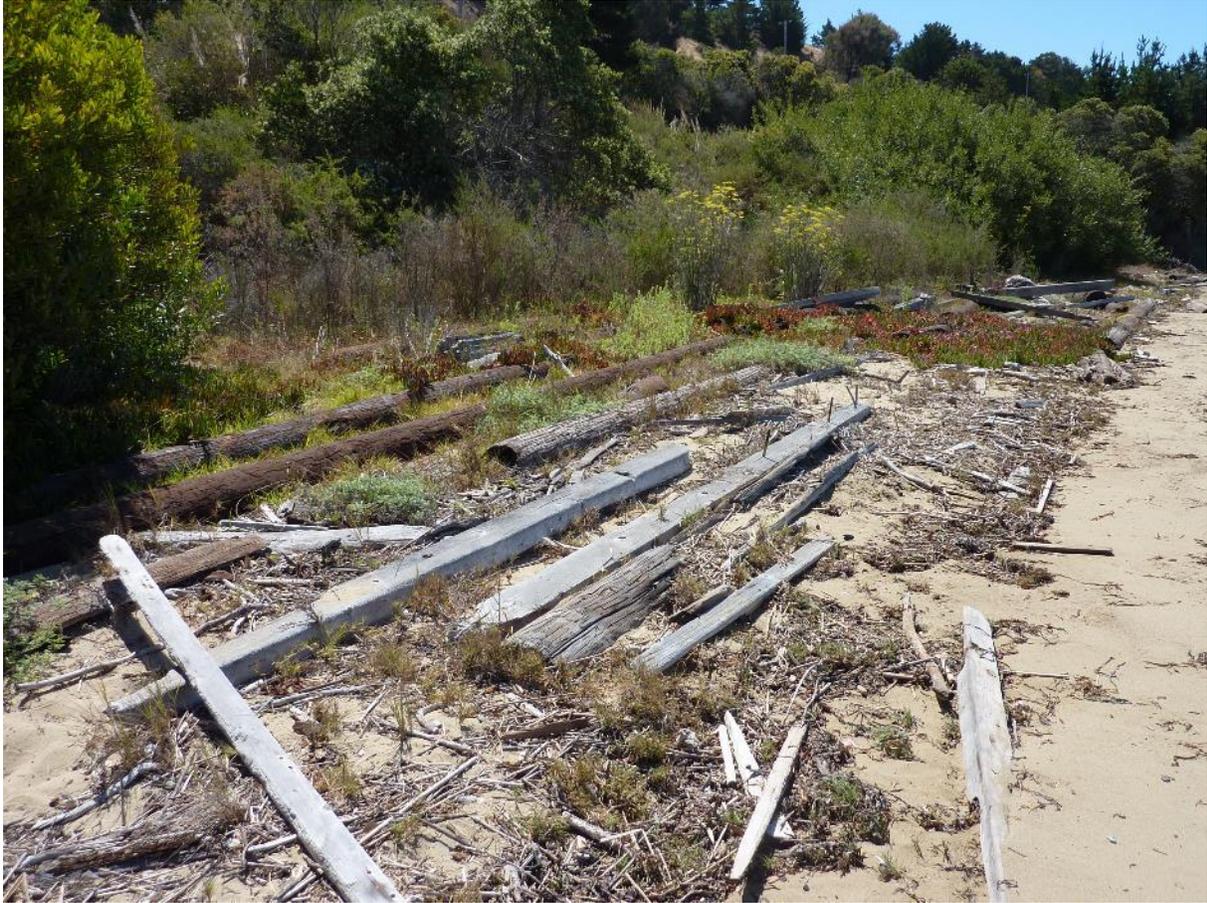
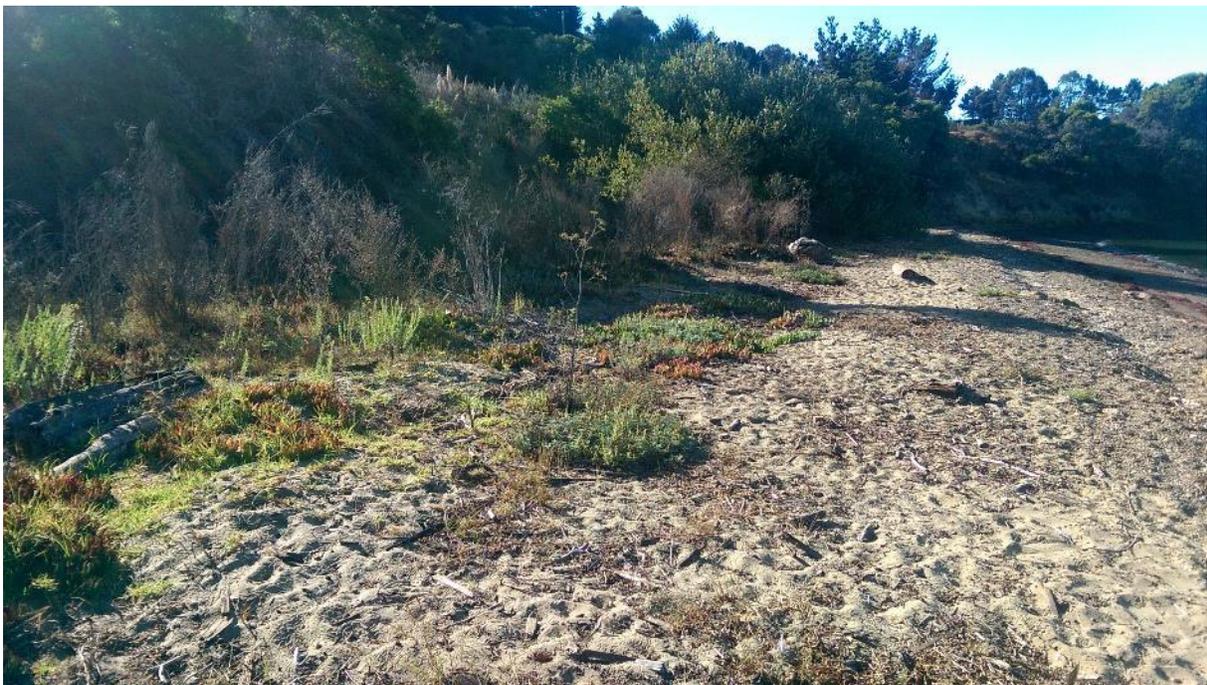
Drift wood and some non-treated wood was left on the beach, though many planks had large nails and stakes in them, which were removed in consideration of public safety. Before (top) and after (bottom)

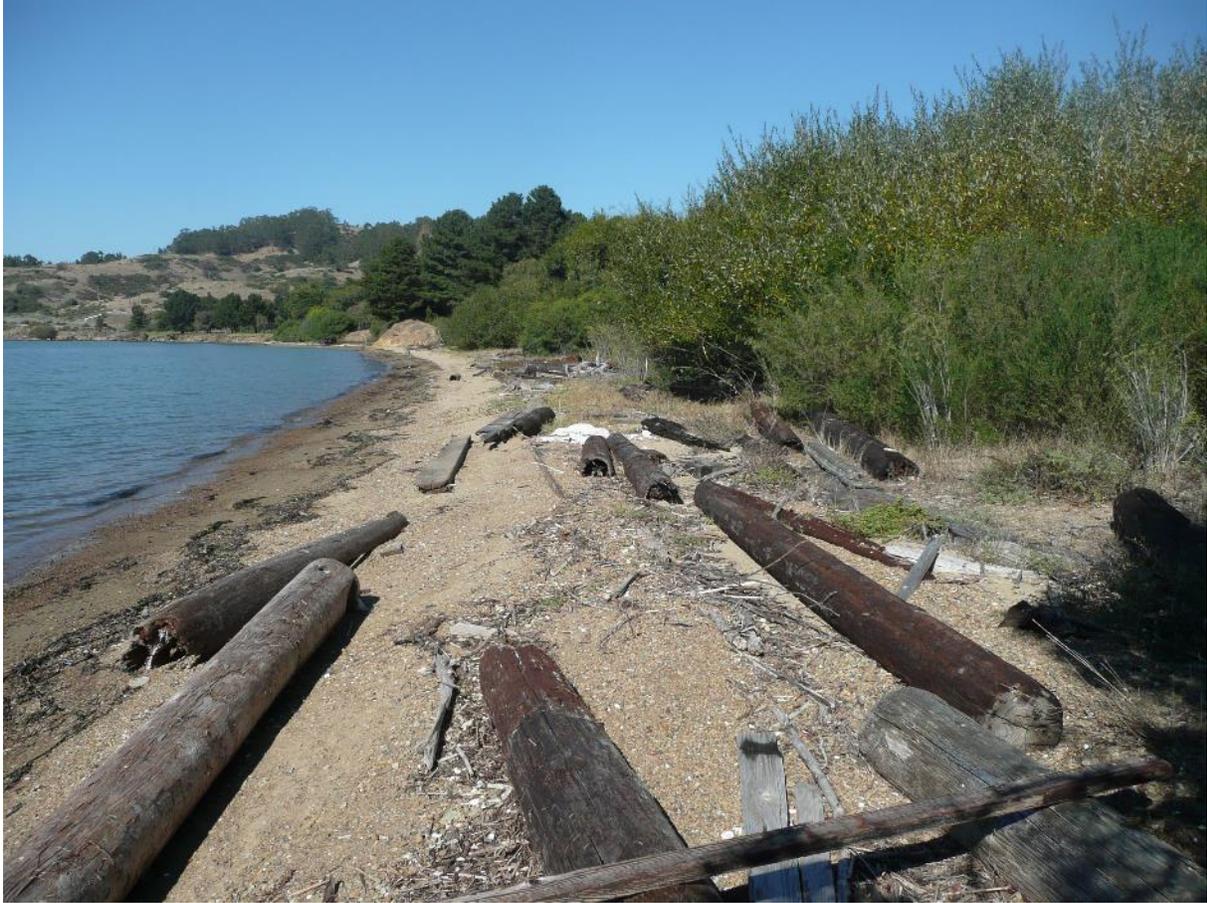
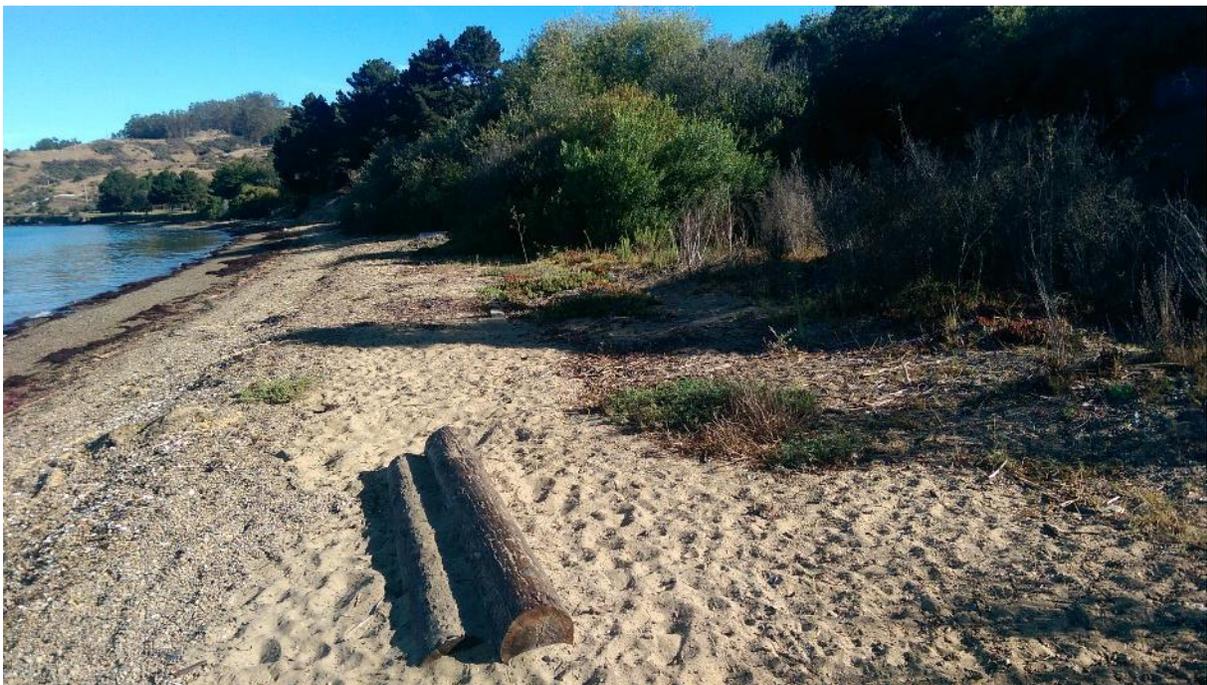
Before – 2012 (top) and after – 2014 (bottom) Some non-contaminated logs were retained

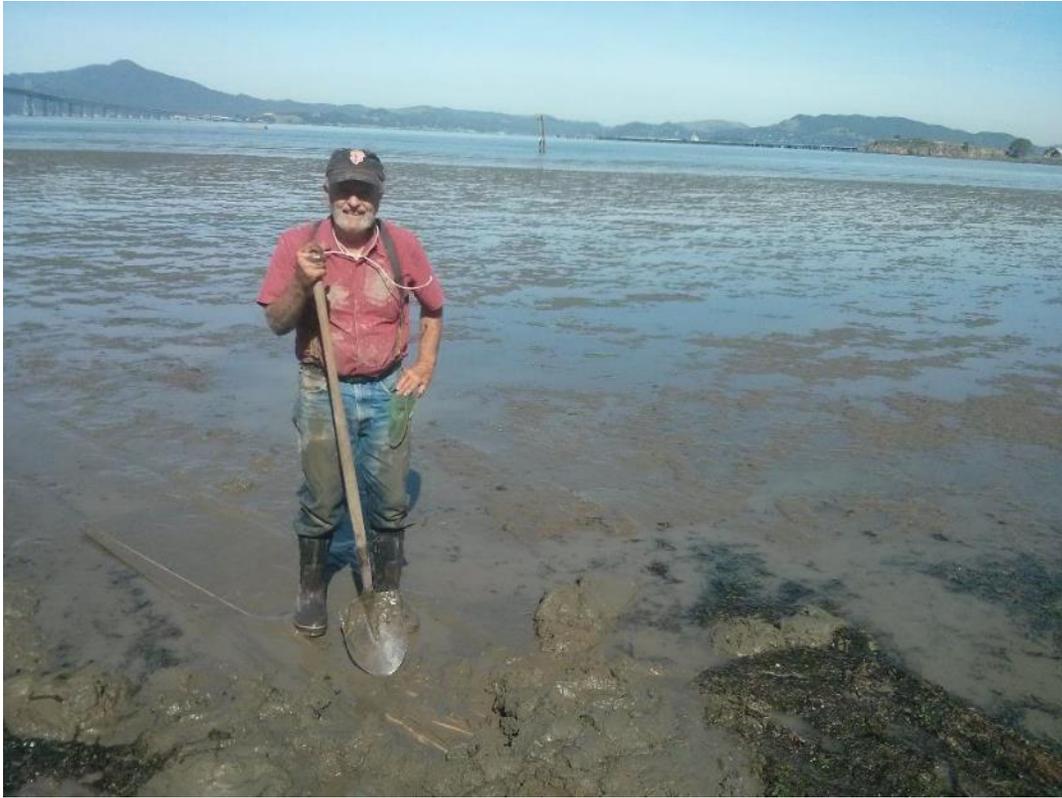
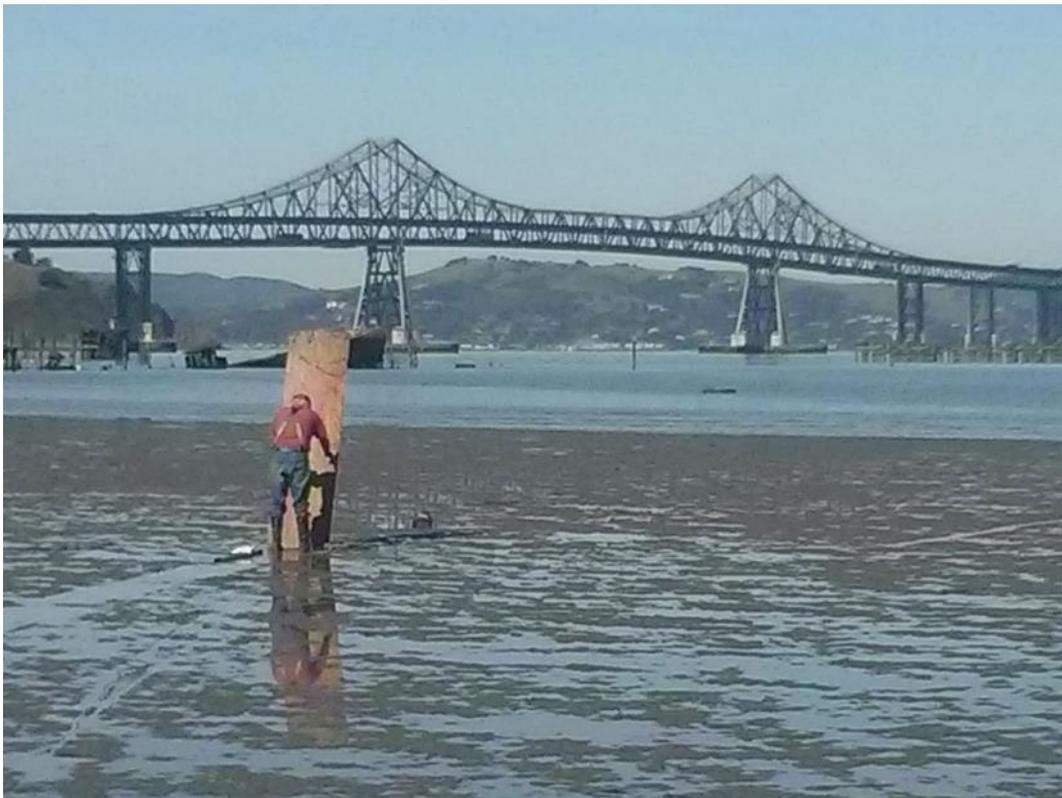
Volunteer using plywood to walk on mudflats to tie ropes on buried tires for extraction from the shore

A single ¼" sheet of plywood was cut lengthwise and rope handles were fixed at either ends. This allowed for walking on the plywood sections over very soft mud as the sections were exchanged in series. Tires located more than 200 ft. from the shore were collected in this manner. Clusters of tires were collected at once, where possible, with multiple ropes ran through a directional on-shore so that a tracked skid steer could run along the beach and pull the tires to shore. Following removal no signs of the drag marks were visible following a single tide cycle. Larger tires required partial extraction with a shovel in-situ, prior to removal.

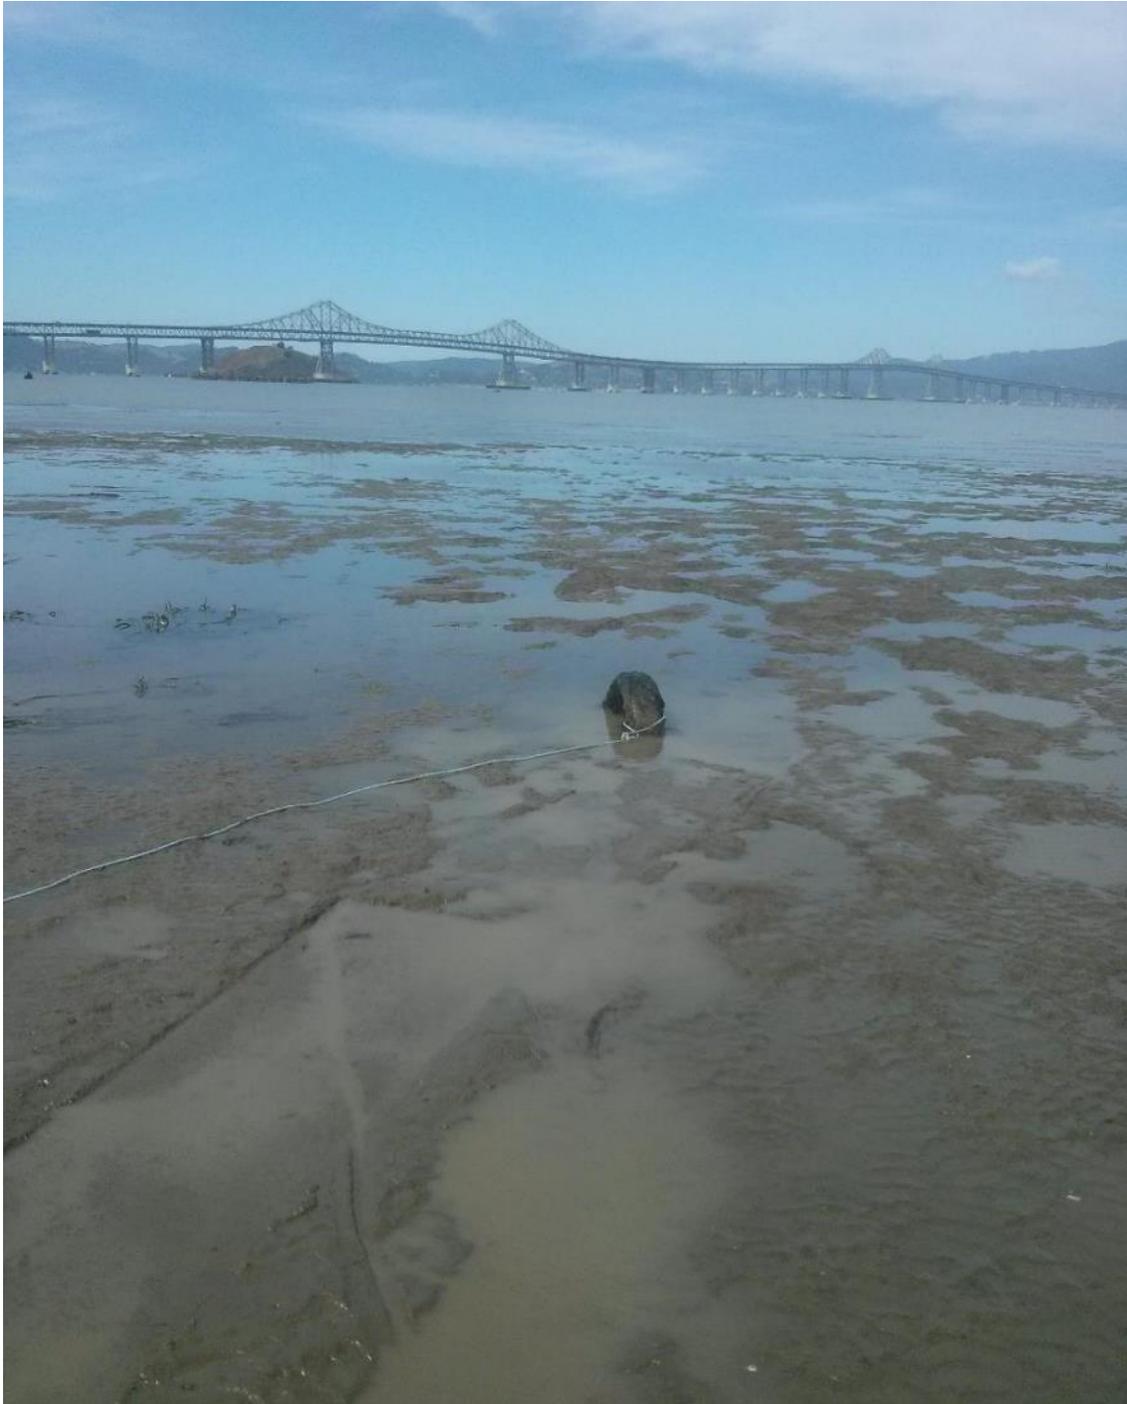
View of sample tire ~50m from the shore with rope tied for extraction. Forty-two (42) tires were extracted from the mudflats using a low-impact technique that proved strenuous yet effective. A single $\frac{1}{4}$ " sheet of plywood was cut lengthwise and rope handles were fixed at either ends. This allowed for walking on mudflats using the plywood sections in series. Clusters of tires were collected at once, where possible, with multiple ropes ran through a directional on-shore so that a tracked skid steer could run along the beach and pull the tires to shore. Following removal no signs of the drag marks were visible following a single tide cycle. Larger tires required partial extraction with a shovel in-situ, prior to removal.

Forty-two (42) tires, ranging from small passenger size to large truck tires, were removed from mudflats adjacent to Point Molate Beach Park. Approximately fifteen additional tires were removed from the shoreline. Extraction of tires from the mudflats was accomplished using a low-impact technique that proved strenuous yet effective (*Appendix 2, Project Photos*).
