COCOS LAGOON ABANDONED TIRE REEF REMOVAL PROJECT

PRINCIPAL INVESTIGATORS:
GUAM ENVIRONMENTAL PROTECTION AGENCY
AND
GUAM DEPARTMENT OF AGRICULTURE

Funded by NOAA Marine Debris Grant (NA19NOS9990031)

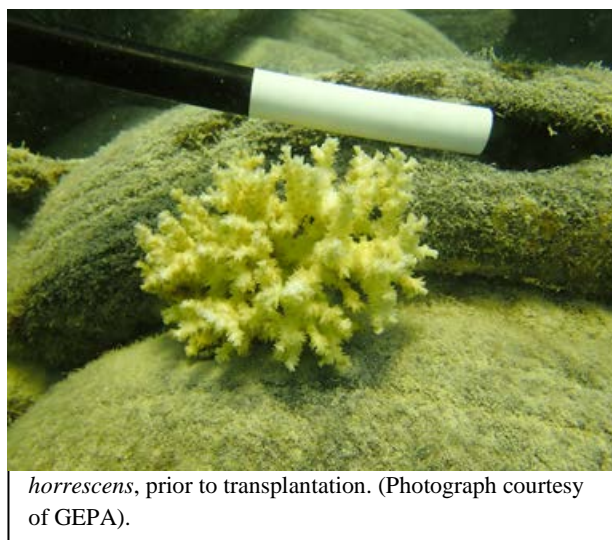
Coral heads and encrusting colonies suitable for transplant were identified, and removed from the tire substrate. Corals were removed by chipping off the living portion of the colony from the point of attachment on the tire using a chisel and hammer. All encrusting species (e.g. *Leptastrea purpurea*, *Pavona chiriquiensis*, *P. varians*) suffered damage (split and shattered) when removed from the tire substrate. Small non-encrusting species were relocated if all or a significant portion of the colony can be removed from the tire intact.

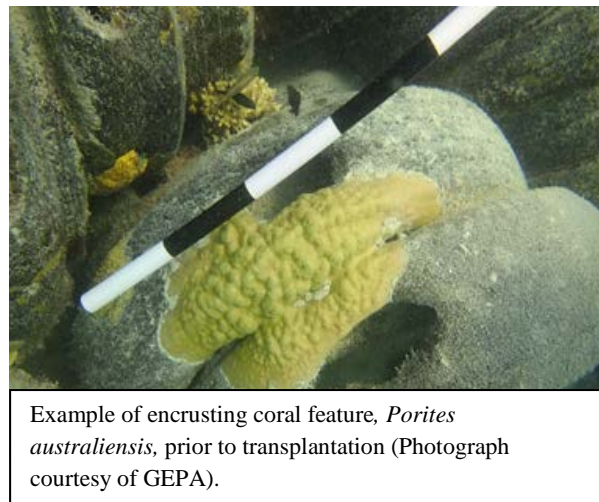
A coral transplant site was identified and prepped for the new coral colonies to be transplanted.

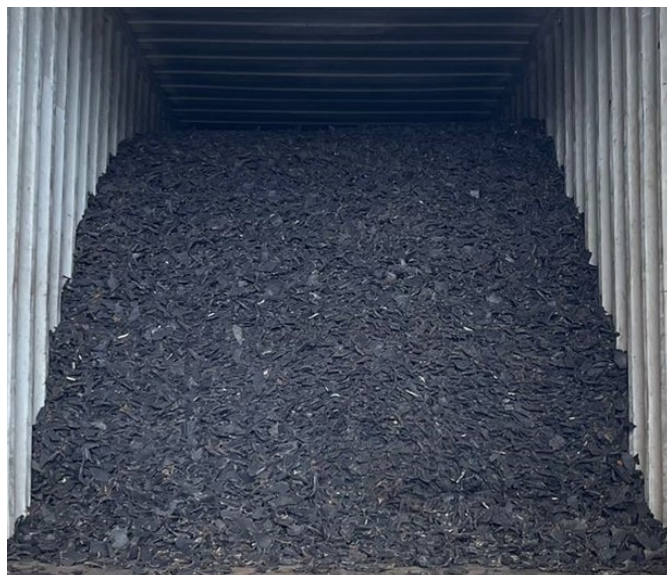
Stock photograph of shredded tires containerized for shipping Tire Processing facility. (Photograph courtesy of Guahan Waste).

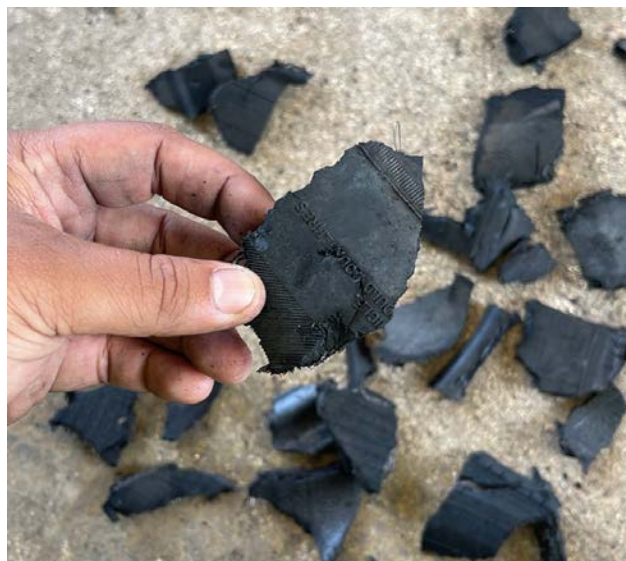
Close-up of Stock photograph of shredded tires. (Photograph courtesy of Guahan Waste).
